Illinois Commerce Commission

Staff's Assessment Report of MidAmerican Energy Company 2010 Reliability Report

August 23, 2012

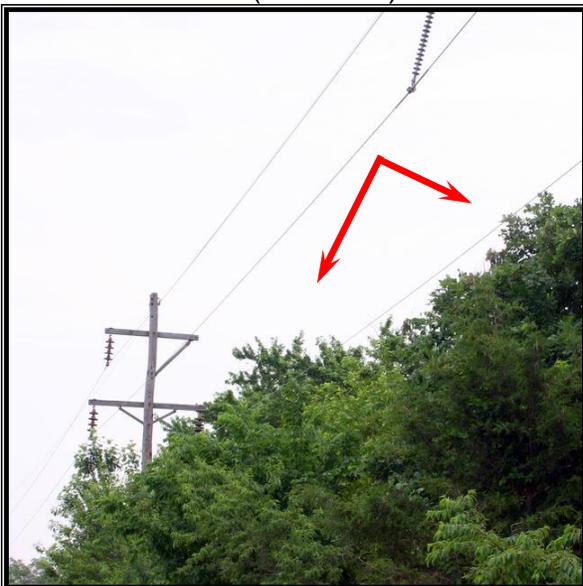
Figure (4)
Trees contact 69 kV line feeding Substation 107 (Photo 71)

Figure (4) is a photo of tree interference with a 69 kV line feeding Substation 107. Figure (2), Figure (3), Figures (5) and (6) are graphical representations of the above analyses.

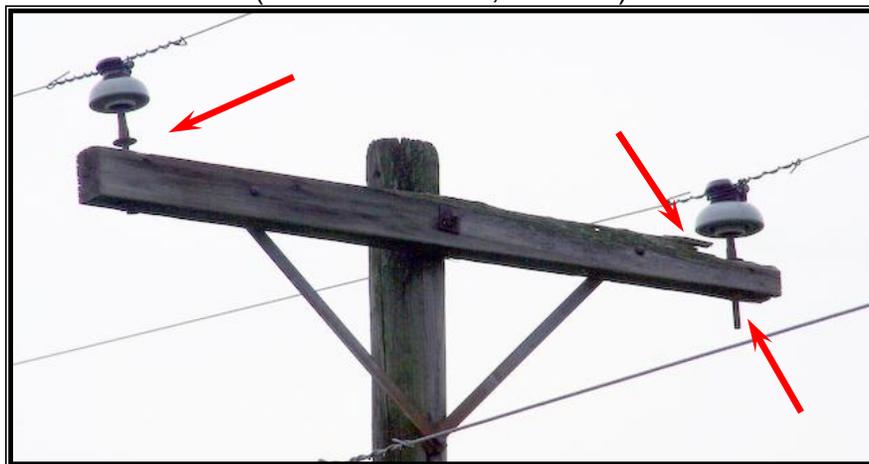
Figure (15)

Loose top pin insulators and decayed crossarm
(Circuit 13-111-2, Photo 4)

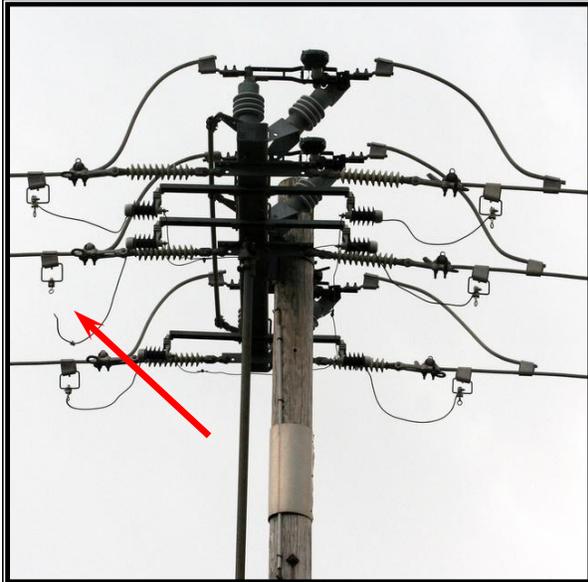
Figure (16)

Disconnected lightning arrester jumper
(Circuit 13-111-2, Photo 3)

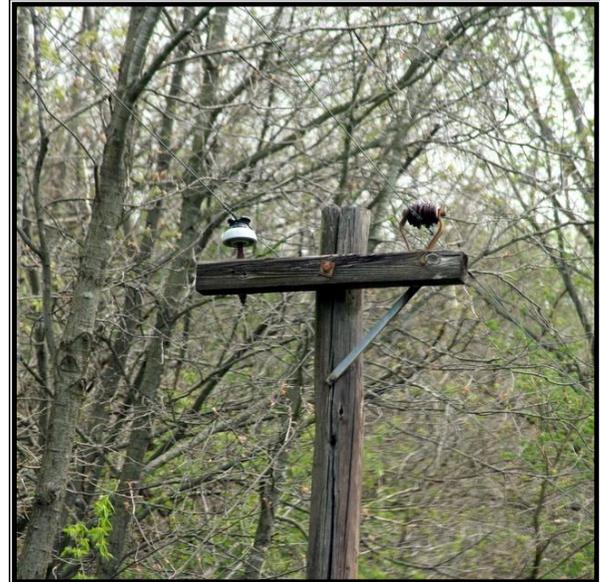
Figure (17)

Missing crossarm brace
(Circuit 13-111-2, Photo 5)

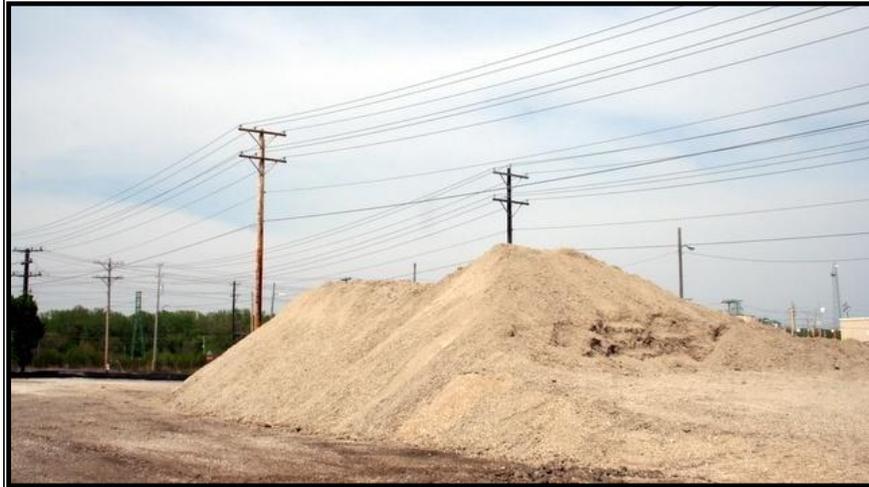
Figure (18)

Pile of sand underneath 13.2 kV lines (Circuit 13-PC-1, Photo 6)

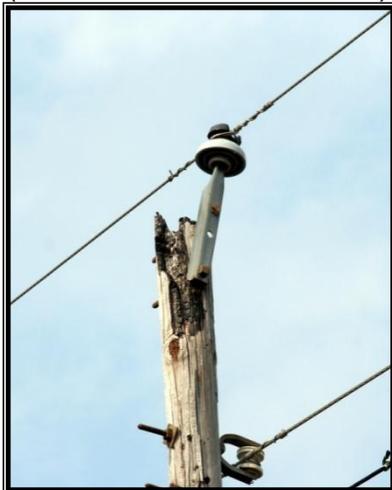
Figure (19)

Burned pole top
(Circuit 13-PC-1, Photo 10)

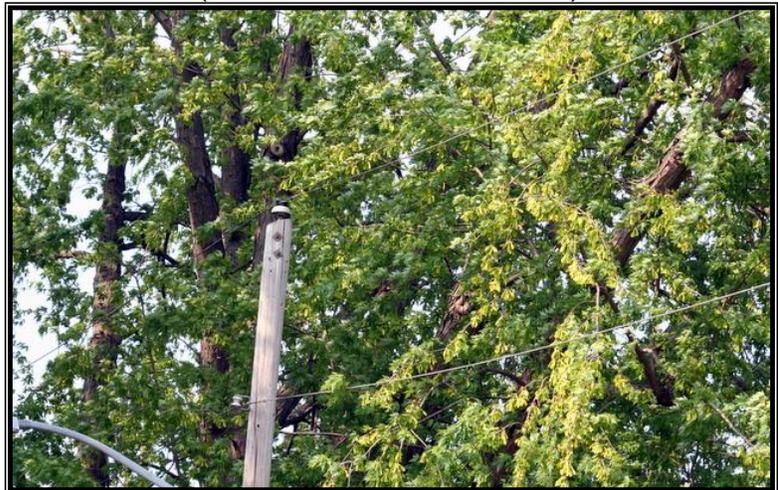
Figure (20)

Trees close to primary wires
(Circuit 13-PC-1, Photo 10)

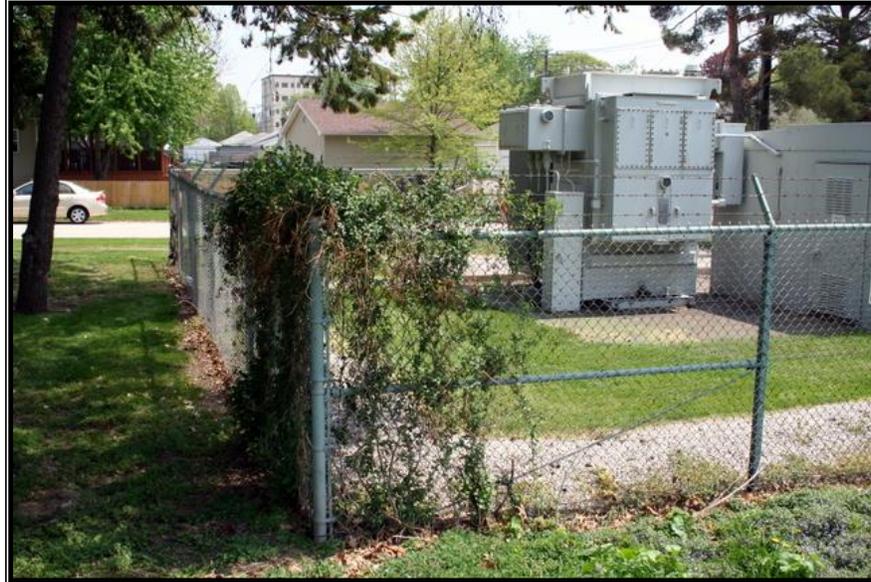
Figure (21)

Weeds growing on the substation fence (Circuit 4-C-4, Photo 22)

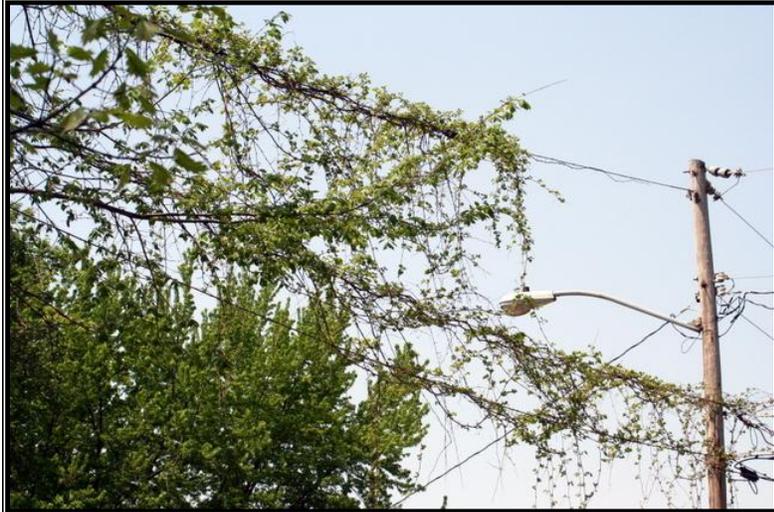
Figure (22)
Vines growing on overhead guy
(Circuit 4-C-2, Photo 29)

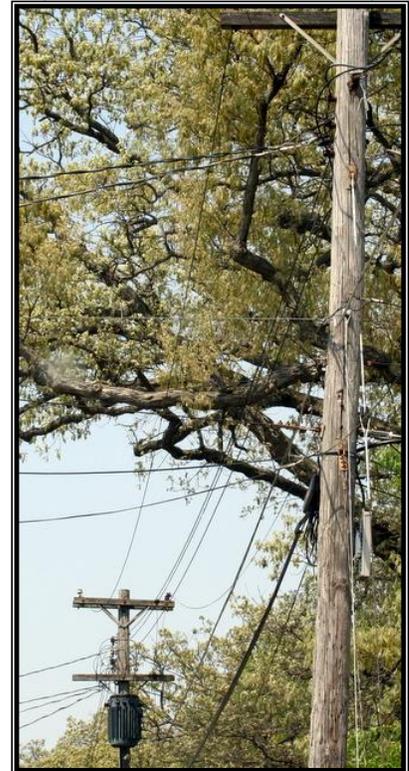
Figure (23)
Tree hanging over lines
(Circuit 4-C-2, Photo 31)

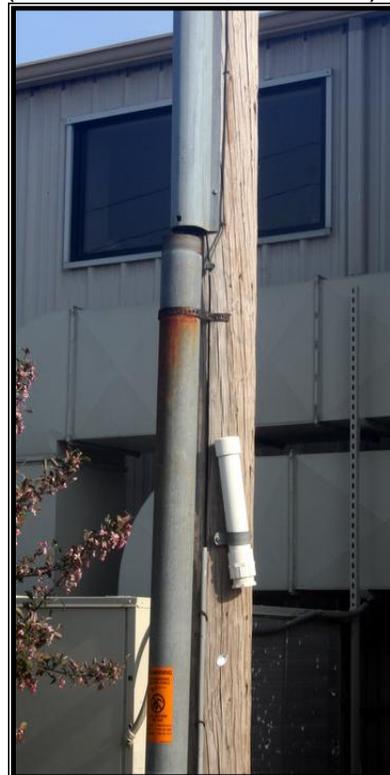
Figure (24)
Broken riser duct
(Circuit 13-38-1, Photo 38)

NESC Rule 314.B requires that “[conductive]-material ducts and riser guards that enclose electric supply lines or are exposed to contact with open supply conductors of greater than 300 V shall be effectively grounded.”

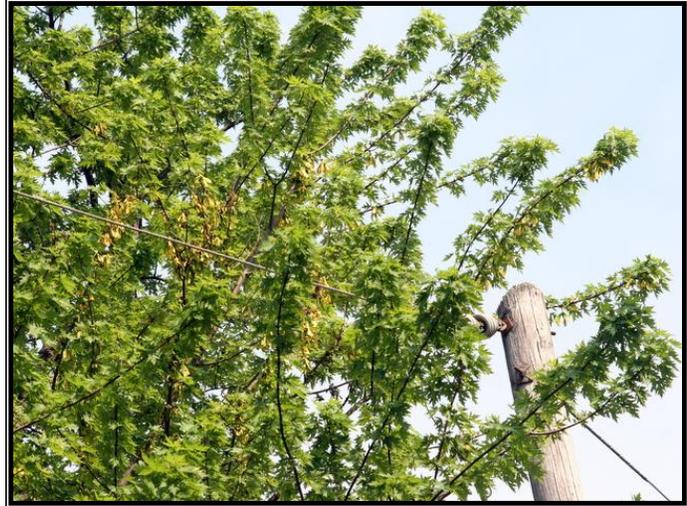
Figure (25) (Right)
Tree contacts primary wire
(Circuit 13-22-1, Photo 47)

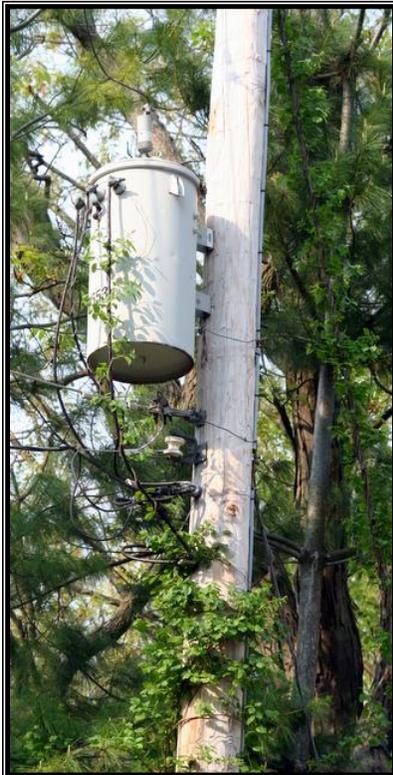
Figure (26)
Vines growing on pole
(Circuit 13-22-1, Photo 42)

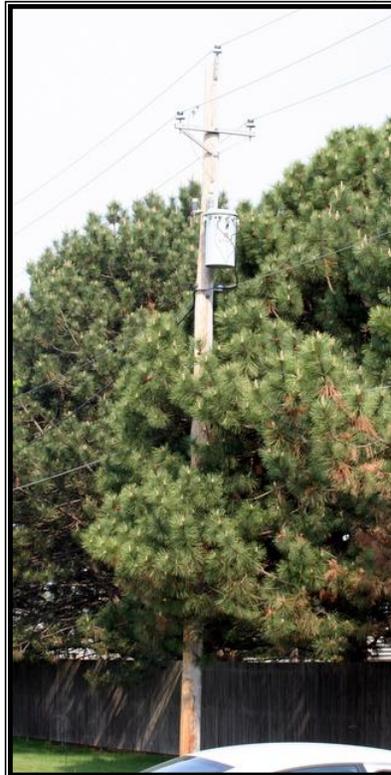
Figure (27)
Pole surrounded by tree
(Circuit 13-22-1, Photo 46)

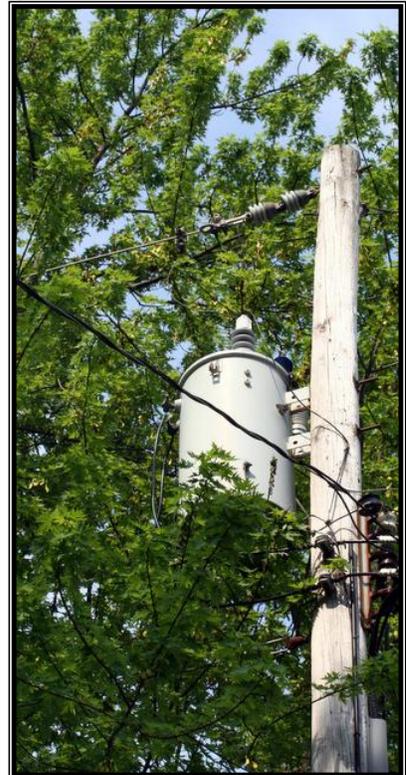
Figure (28)
Tree surrounds transformer
(Circuit 13-22-1, Photo 48)

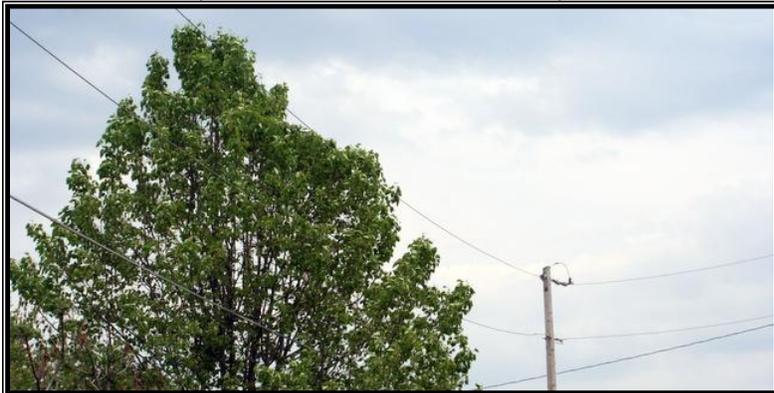
Figure (29)
Tree contacts primary wire
(Circuit 13-47-1, Photo 54)

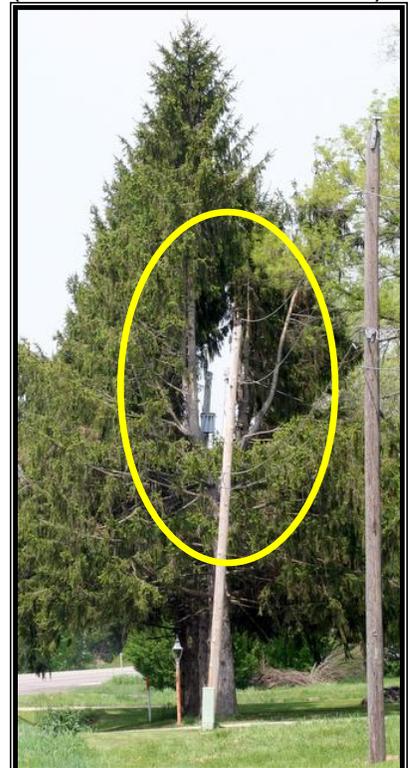
Figure (31)
Supply wires run through
an opening carved
between tree branches
(Circuit 13-47-1, Photo 56)

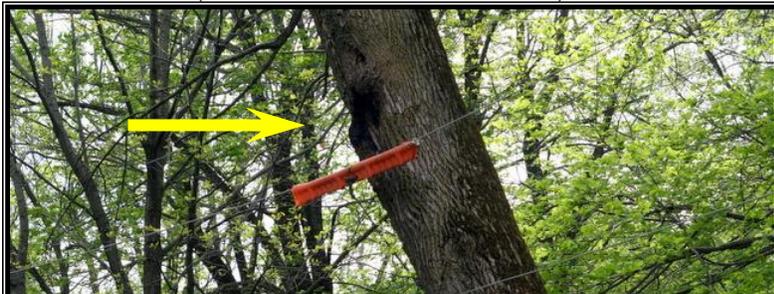
Figure (30)
Burns on tree trunk due to primary wire contact
(Circuit 13-47-1, Photo 61)

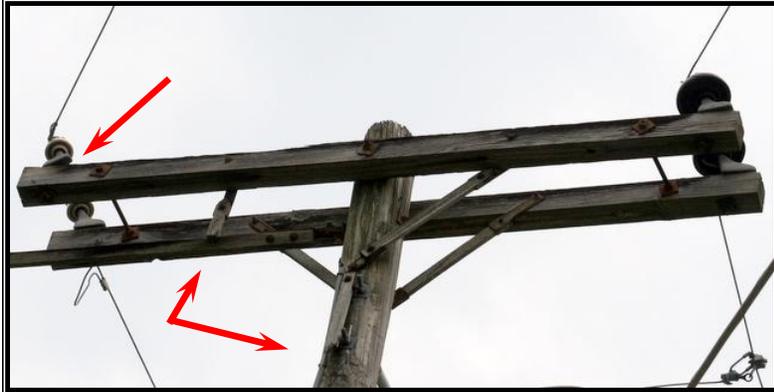
Figure (32) (Left)
Broken crossarm brace
and twisted (loose) neutral
pin insulator
(Circuit 13-47-1, Photo 60)

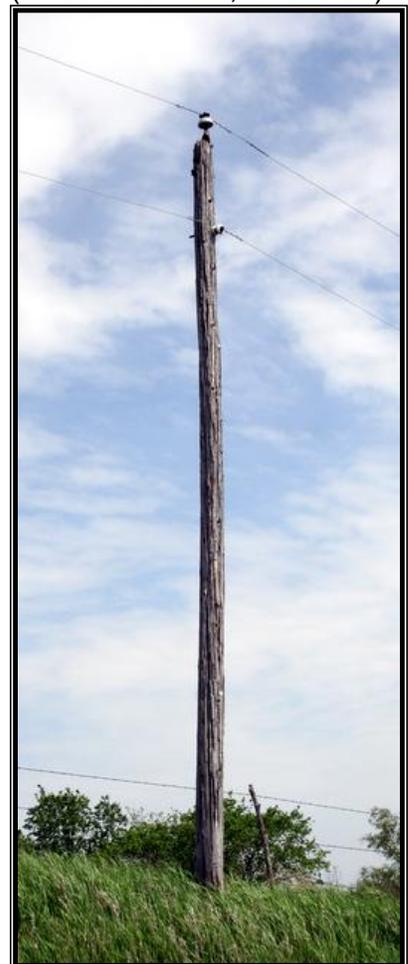
Figure (33)
Shell rotted pole
(Circuit 13-27-1, Photo 67)

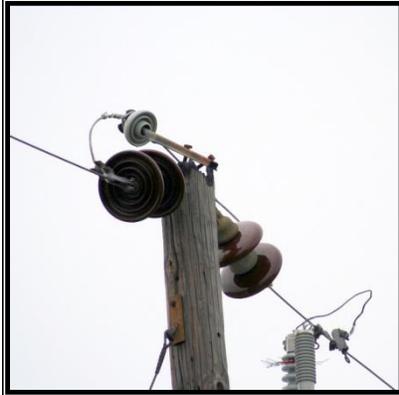
Figure (34)

Loose primary pin insulator
(Circuit 13-27-1, Photo 68)

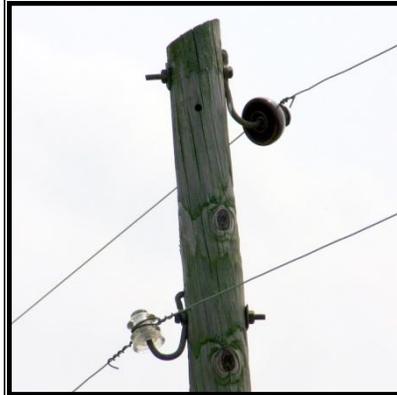
Figure (35)

Bent primary insulator
(Circuit 13-107-1, Ph. 78)

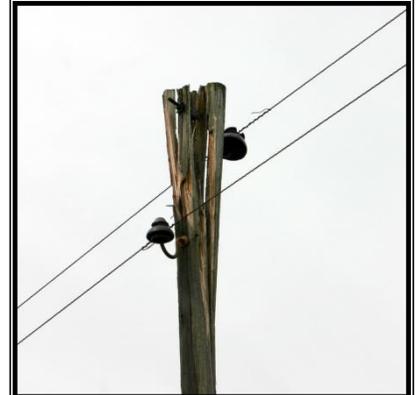
Figure (36)

Lightning struck pole
(Circuit 13-107-1, Ph. 108)

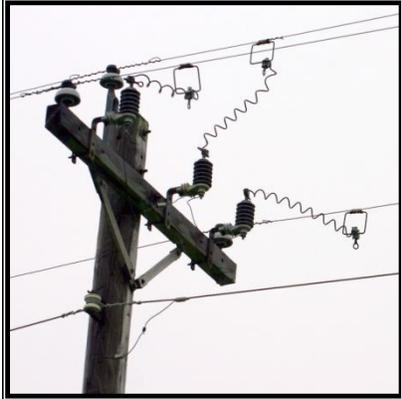
Figure (37)
Coiled lightning arrestors jumpers (Circuit 13-107-1, Photo 105)

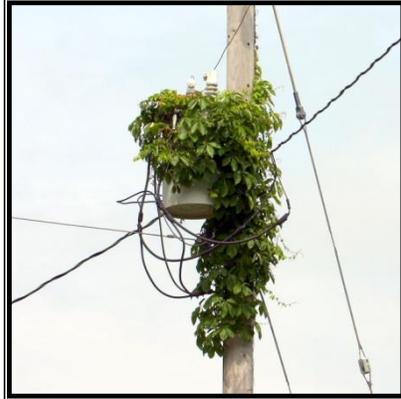
Figure (38)
Transformer enveloped by vine (Circuit 13-107-1, Photo 114)

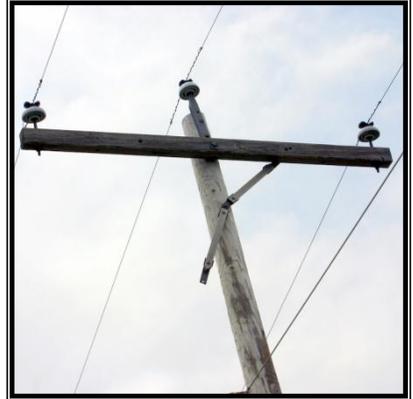
Figure (39)
Disconnected crossarm brace (Circuit 13-107-1, Photo 115)

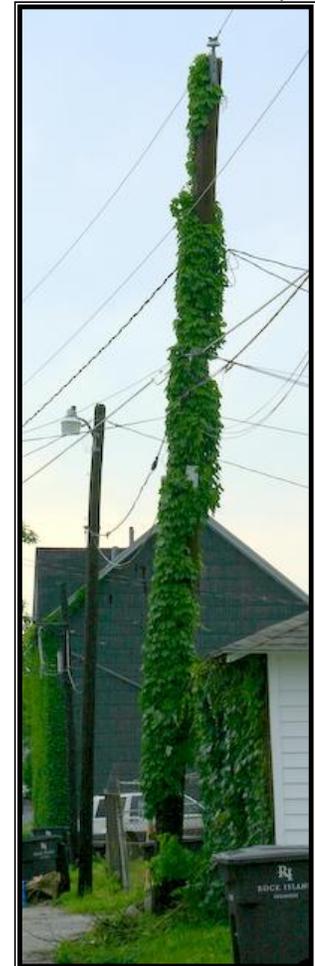
Figure (40)
Vines on pole (Circuit 13-P-3-IL, Ph. 86)

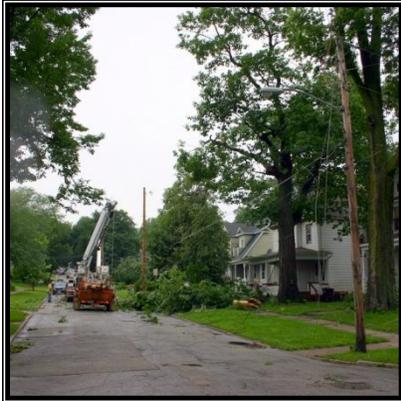
Figure (41)
Primary wire knocked
down by a fallen tree
branch (13-P-3-IL, Ph. 90)

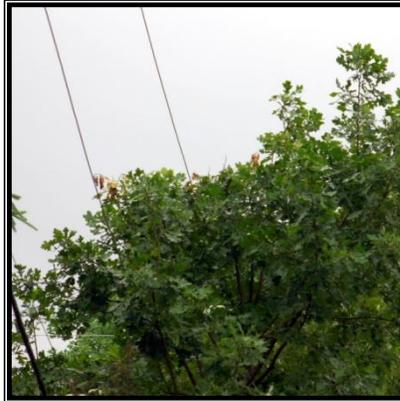
Figure (42)
Tree contacts primary wire
(Circuit 13-P-3-IL,
Photo 91)

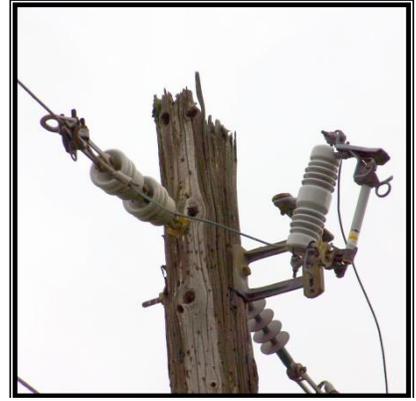
Figure (43)
Deteriorated pole top
(Circuit 13-P-3-IL,
Photo 85)
