Illinois Commerce Commission
Assessment of
MidAmerican Energy Company's
Annual Reliability Report and
Electric Service Reliability
For Calendar Year 2005

Pursuant to 83 Ill. Adm. Code 411.140

December 2006

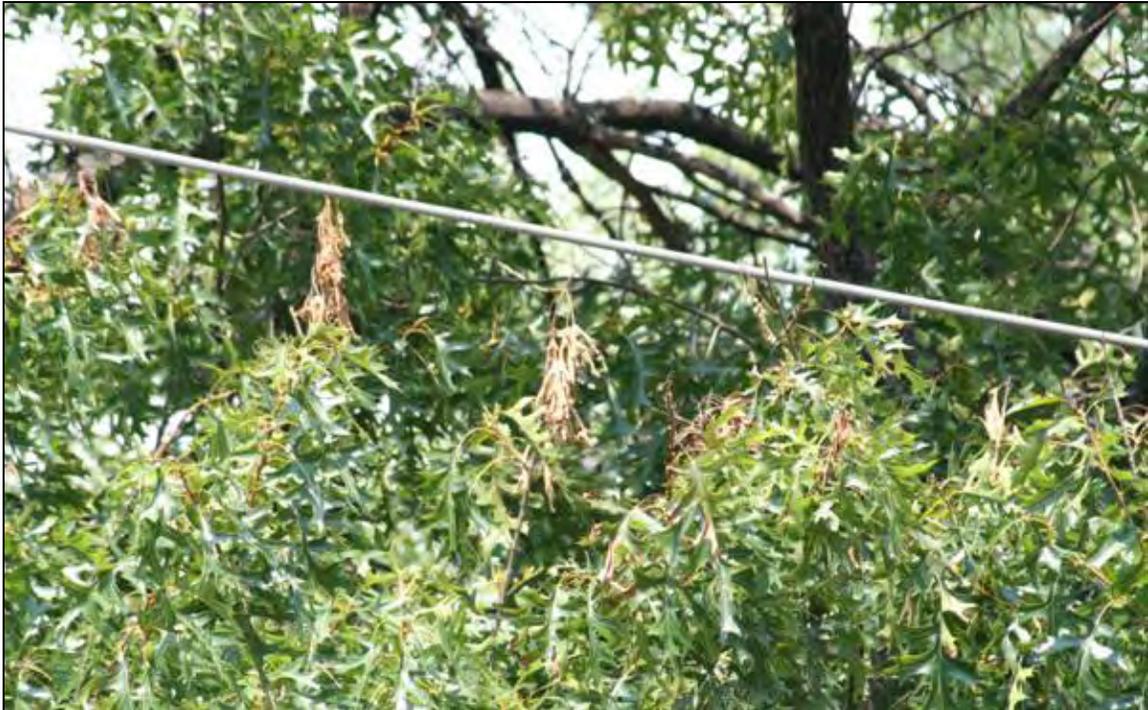
Staff's 2006 inspection identified only four locations where threats to reliable service were visible, and MEC appeared to already be aware of two of those locations, as two deteriorated poles had already been marked for replacement. Staff noted one additional deteriorated pole and one location along 4th Avenue, in Silvis, where several trees were contacting or very close to the conductor (Photo 1). These trees were apparently not trimmed at the time MEC trimmed trees along the rest of the circuit, in October of 2005.

Photo 1: Oak tree growing into and burning on primary wires (Q48202)

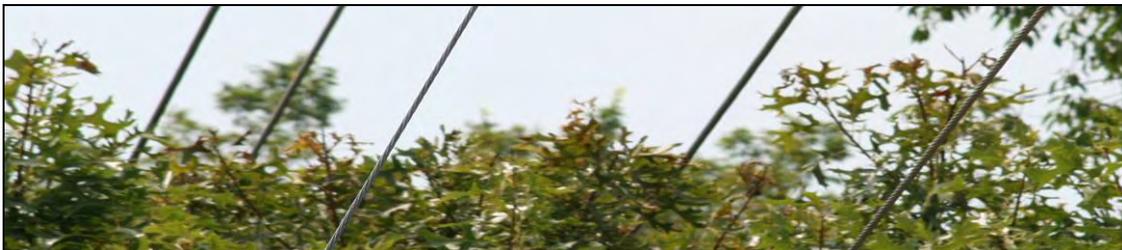
During its inspection of Circuit 13-28-2 Staff noted trees contacting the primary conductor at three locations (examples are shown in Photos 2 & 3), and noted four locations where vines had grown to the primary level (an example is shown in Photo 4). Staff was concerned by the high number of detached or failing cross arm braces on the circuit (see Photos 4-7). Staff was pleased with MEC's placement of lightning arresters, but observed at least seven that were blown. Staff observed several locations with deteriorated or damaged cross arms and pole tops, or loose or damaged hardware (see Photos 7-9). Based on the numerous locations with deteriorated facilities, Staff would not be surprised if Circuit 13-28-2 exhibited poor performance again in 2006.

Photo 2: Oak tree growing through primary (13-28-2)

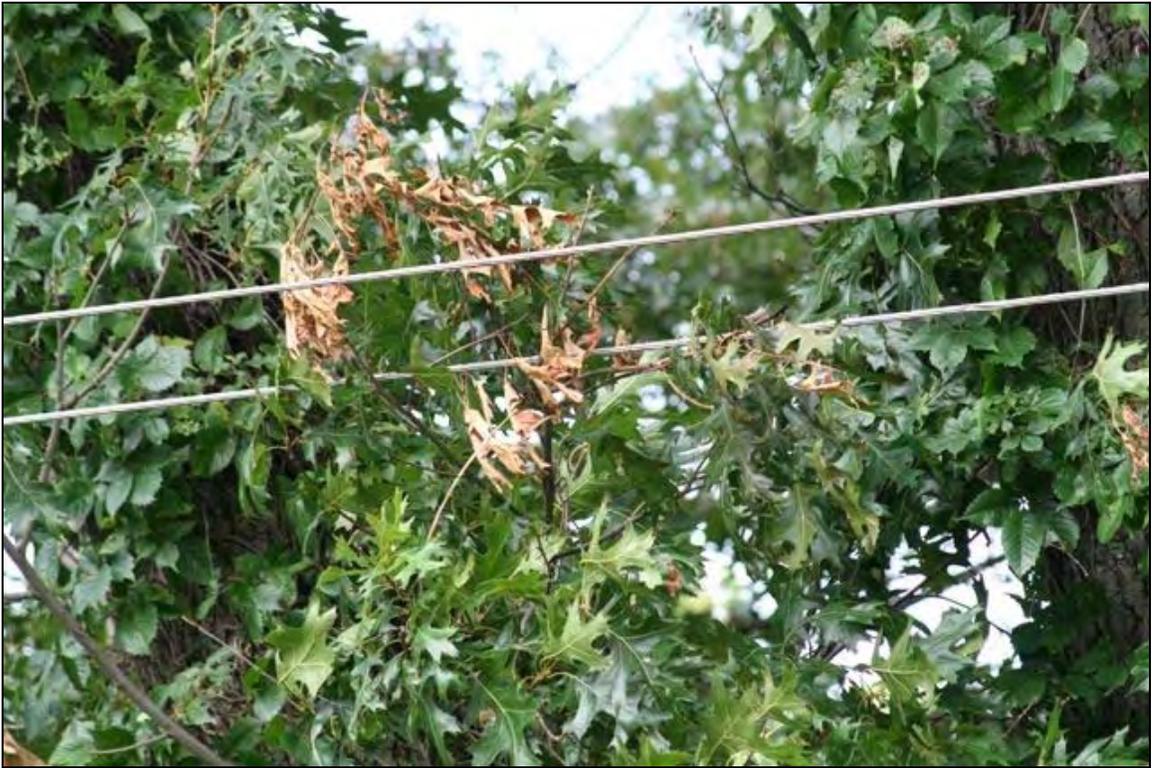
Photo 3: Oak tree grown through/around primary and burning (13-28-2)

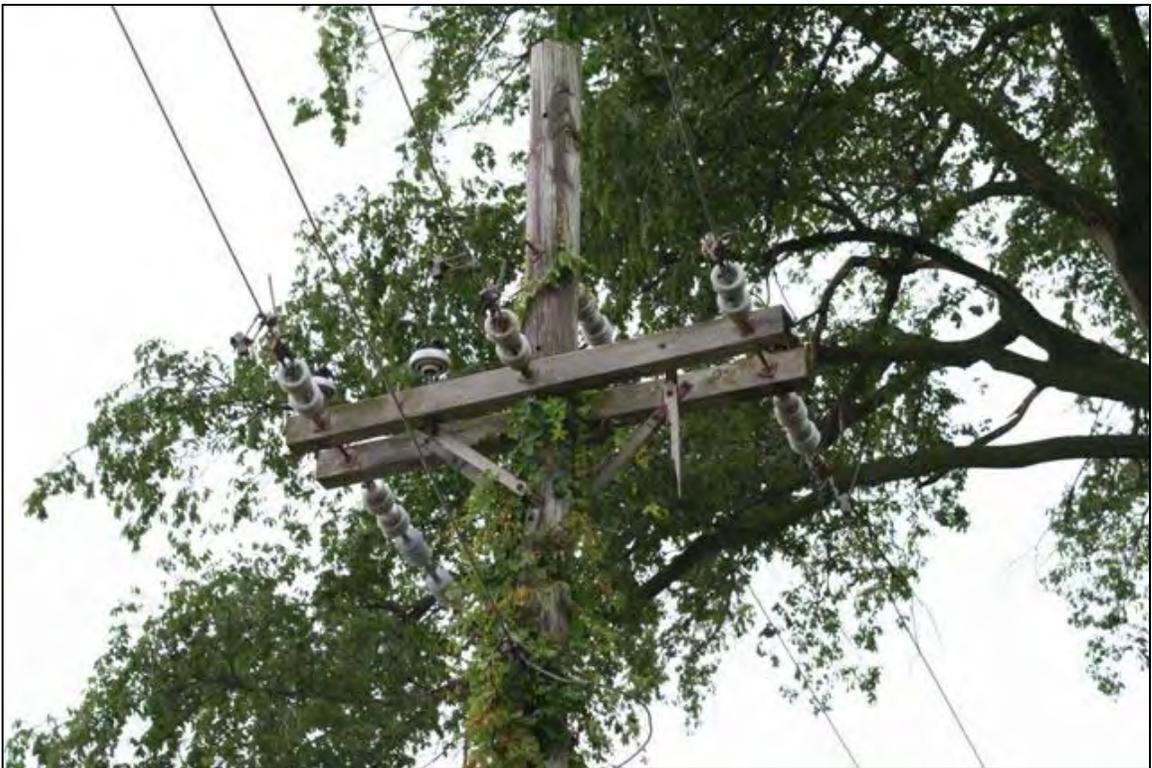
Photo 4: Vine grown up pole to primary level –also a broken cross arm brace (13-28-2)

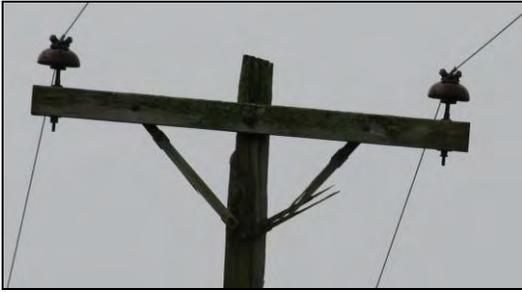
Photo 5: Failing brace (13-28-2)

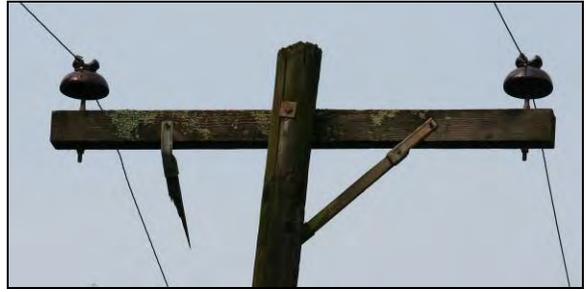
Photo 6: Failed brace (13-28-2)

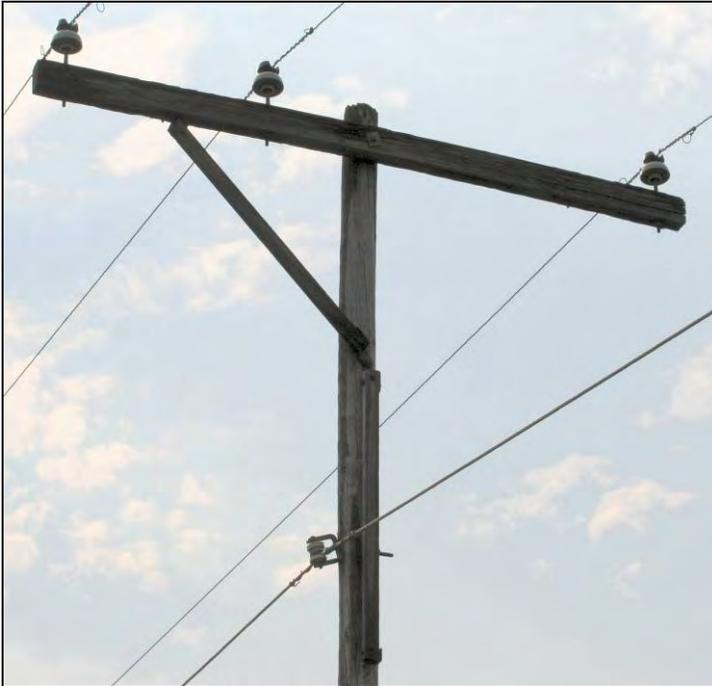
Photo 7: Splitting arm with brace detached & hanging (13-28-2)

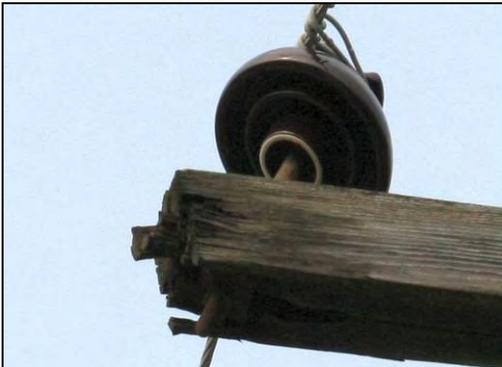
Photo 8: Deteriorated arm (13-28-2)

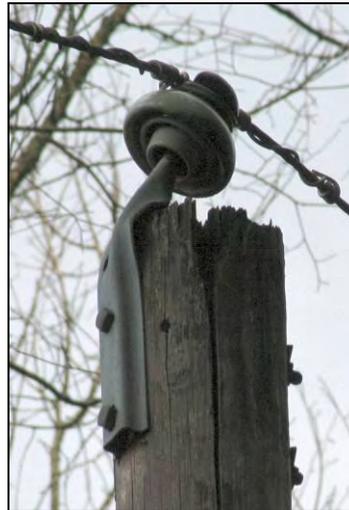
Photo 9: Damaged pole top pin (13-28-2)
