Illinois Commerce Commission

Staff's Assessment Report of
Mt. Carmel Public Utility Company
2009 Reliability Report

July 12, 2011

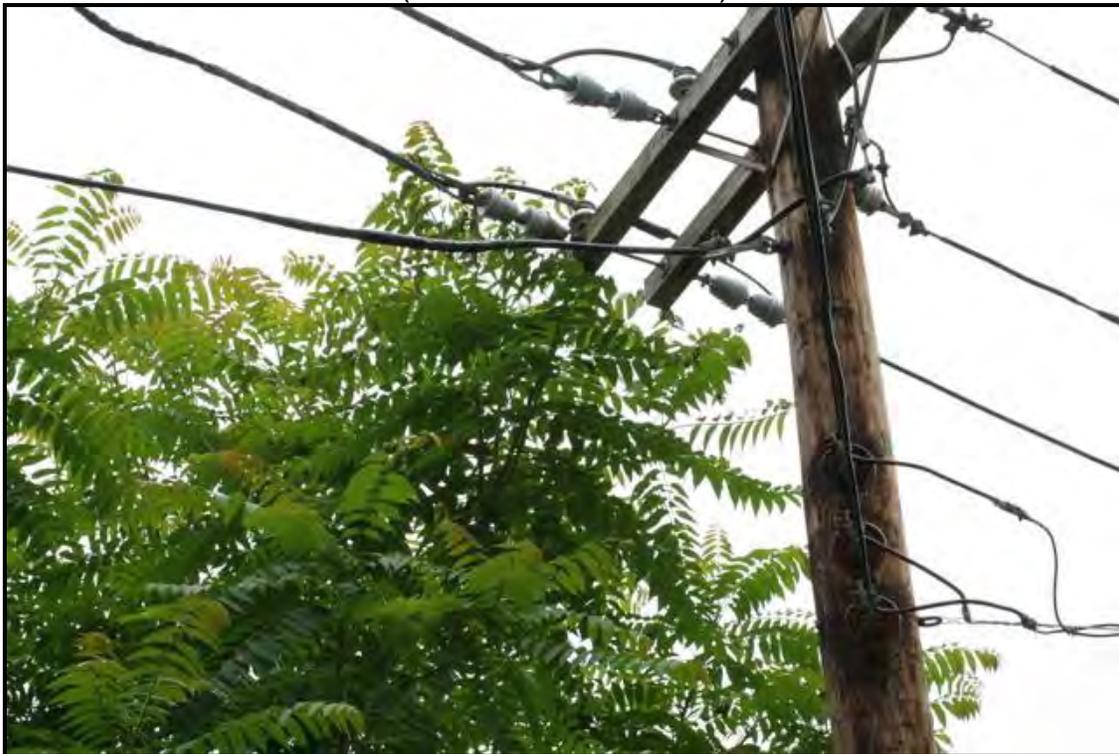
Figure (12)
Tree contacts primary wire
(Circuit 21000-Photo 5)

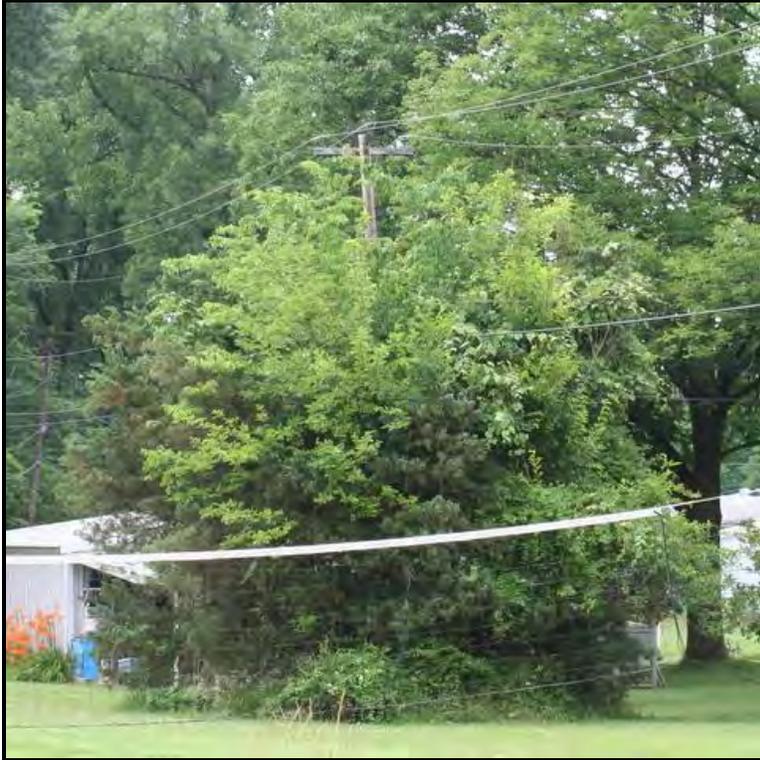
Figure (13)

Pole enveloped by vegetation (Circuit 21000-Photo 8)

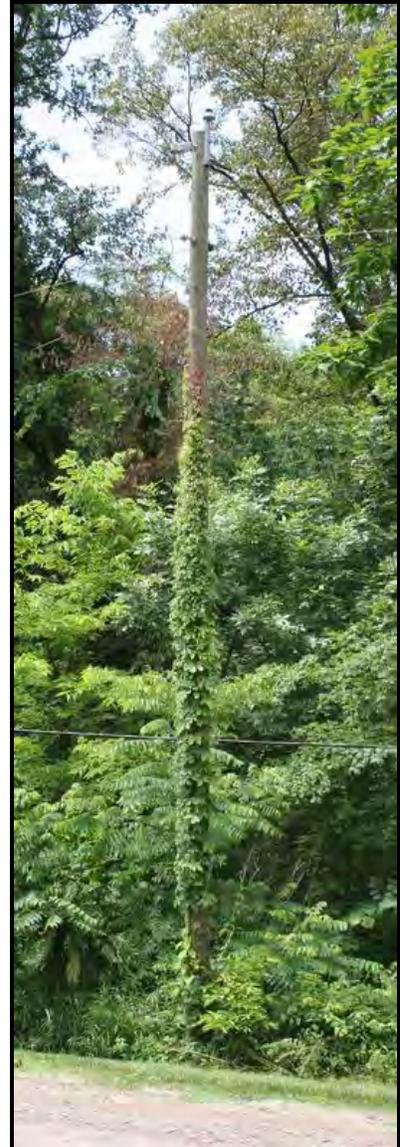
Figure (15)

Vine growing on pole
(Circuit 21000-Photo 30)

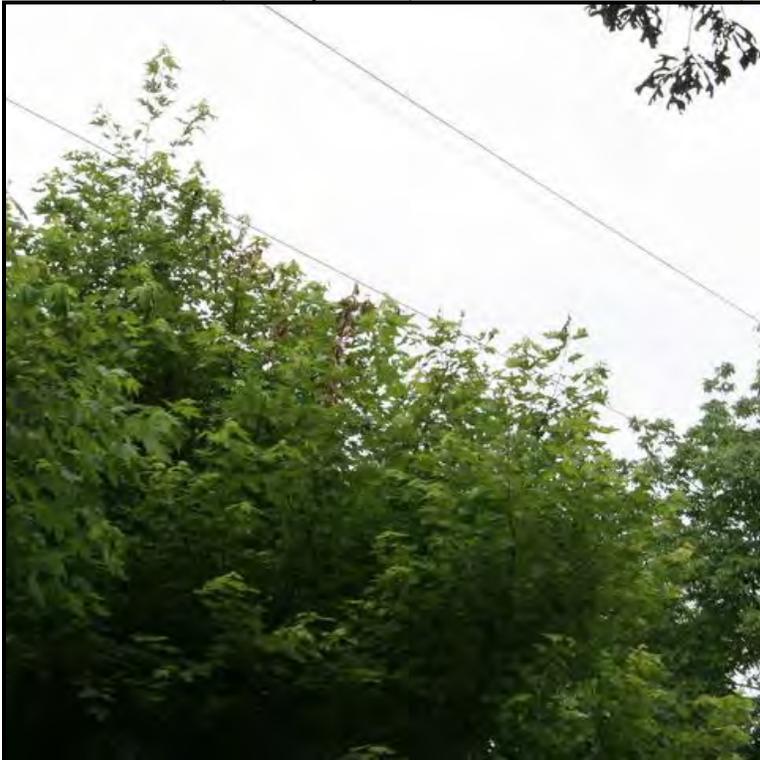
Figure (14)

Tree contacts primary wire (Circuit 21000-Photo 19)

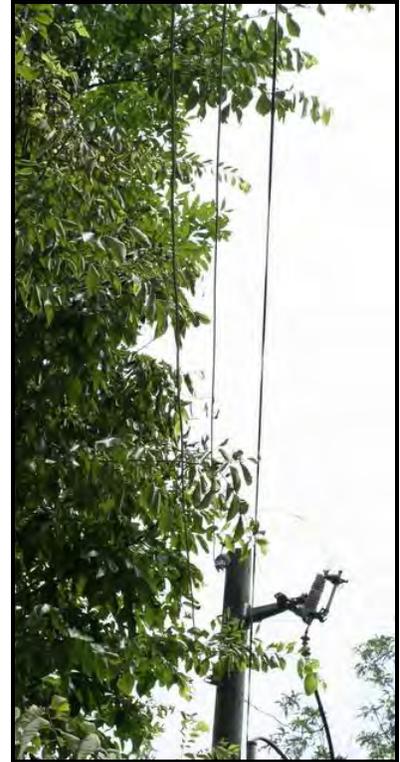
Figure (16) (Right)
Primary runs through a tree
(Circuit 21000-Photo 31)

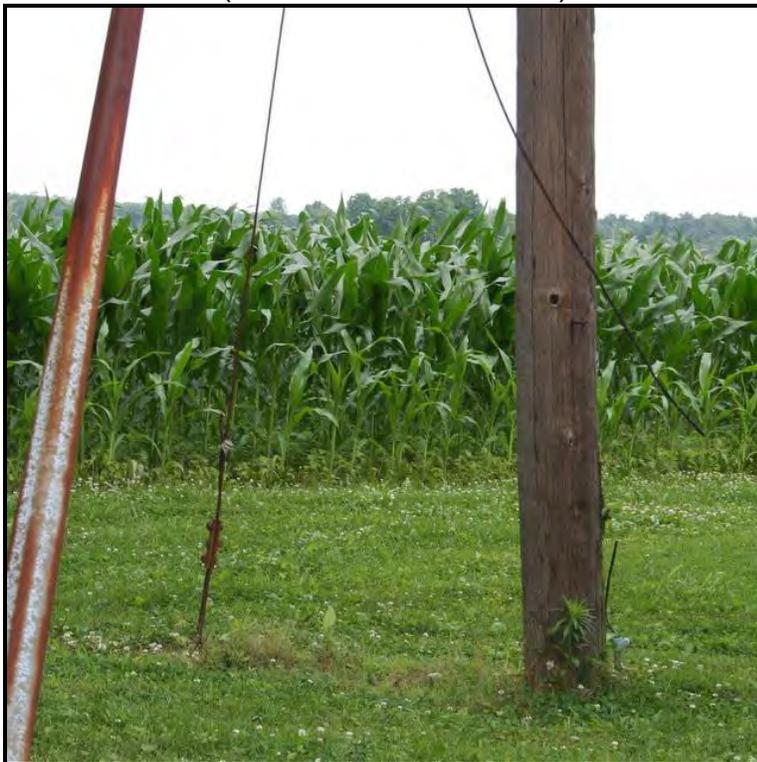
NESC Rule 264.E.1 states, "The ground end of anchor guys exposed to pedestrian traffic shall be provided with a substantial and conspicuous marker." Staff found NESC violations relating to down guys in thirteen locations. Figure (17) is an example of such situations. NESC Rule 234.C.1.a specifies the clearances of wires, cables, and rigid live parts from buildings and other structures. Staff recorded one primary wire NESC clearance violation, namely the primary wire above the rooftop of the garage of 110 Greenview Dr. Staff found one secondary wire NESC vertical clearance violation. Staff found a few instances of facility damage such as the ones pictured in Figures (18) and (19). There is a noticeable lack of animal protection for the overhead transformers throughout the circuit.

Figure (17)
Missing guy guard and disconnected ground wire
(Circuit 21000-Photo 24)

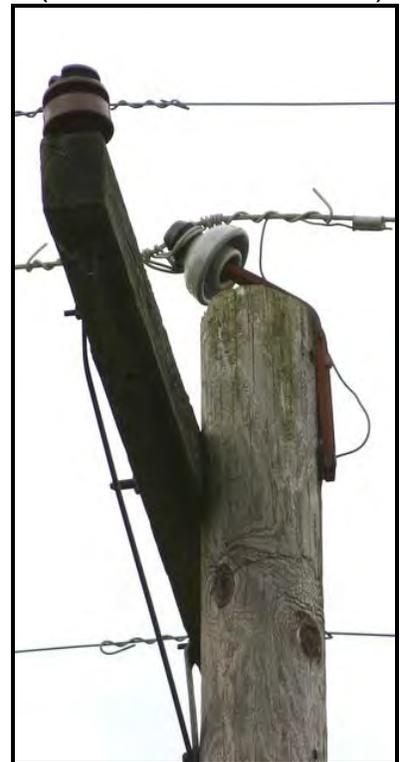
Figure (18)
Bent top insulator pin
(Circuit 21000-Photo 21)

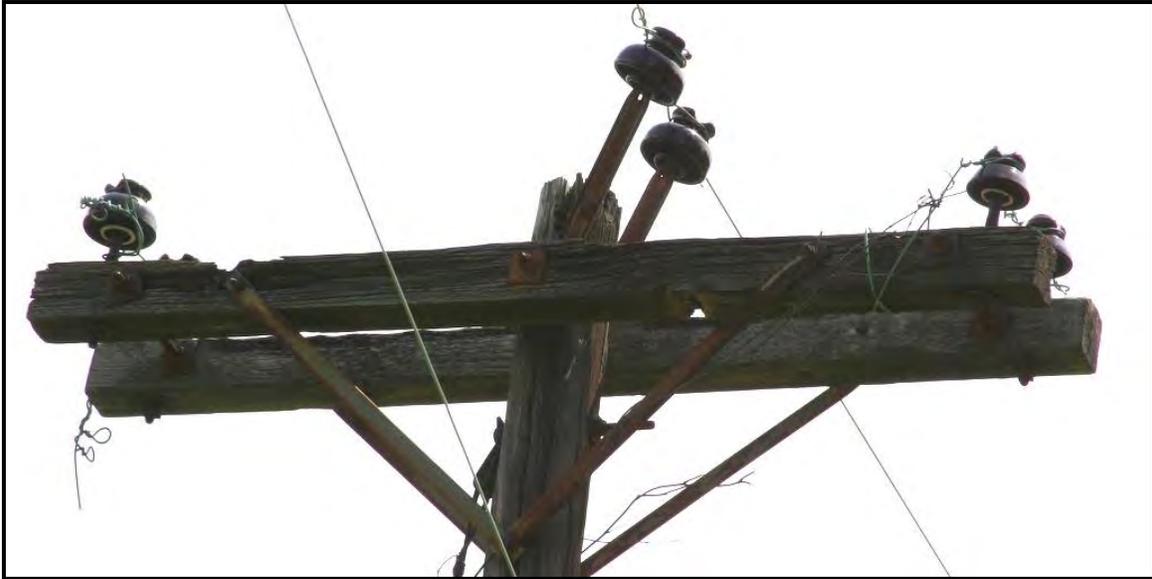
Figure (19)

Loose top insulator pin, deteriorated pole top and deteriorated crossarm (Circuit 21000-Photo 26)

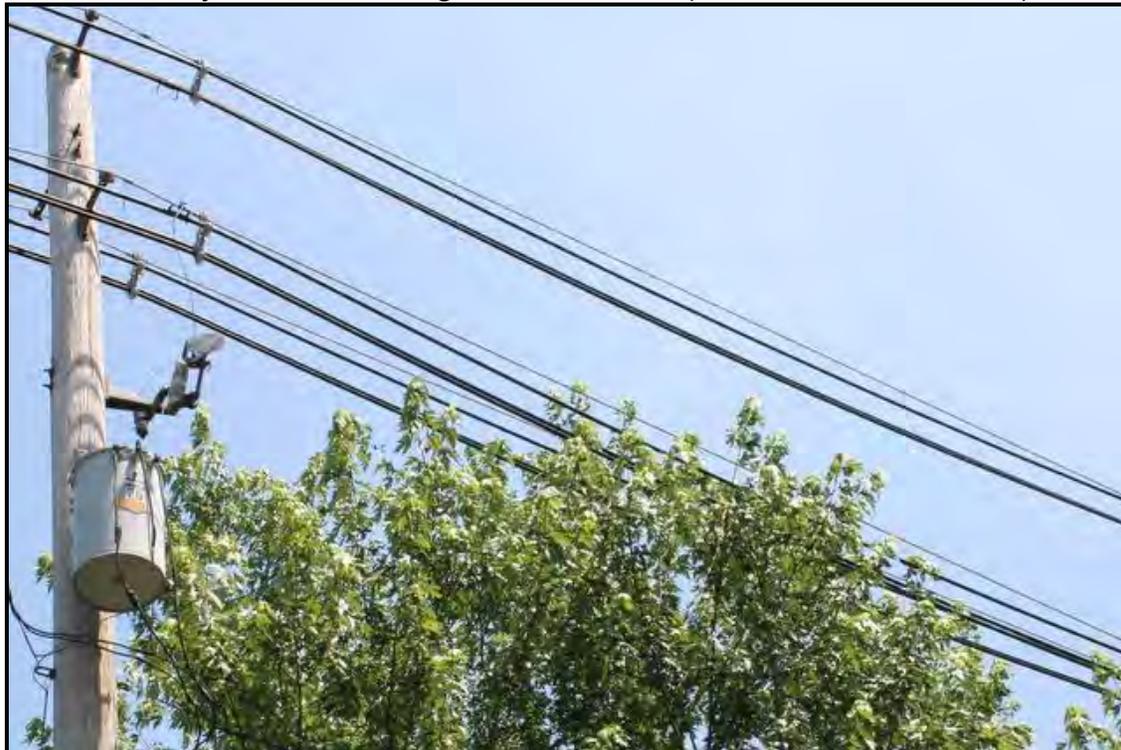
During Staff's inspection of this circuit, Staff recorded 37 observations that Staff believed might cause a threat to reliability on this circuit. Twenty-six of those observations involved vegetation conflicts with overhead primary cables. Figure (20) depicts one of these situations.

Figure (20)
Primary wires run through tree branches (Circuit 31000-Photo 44)

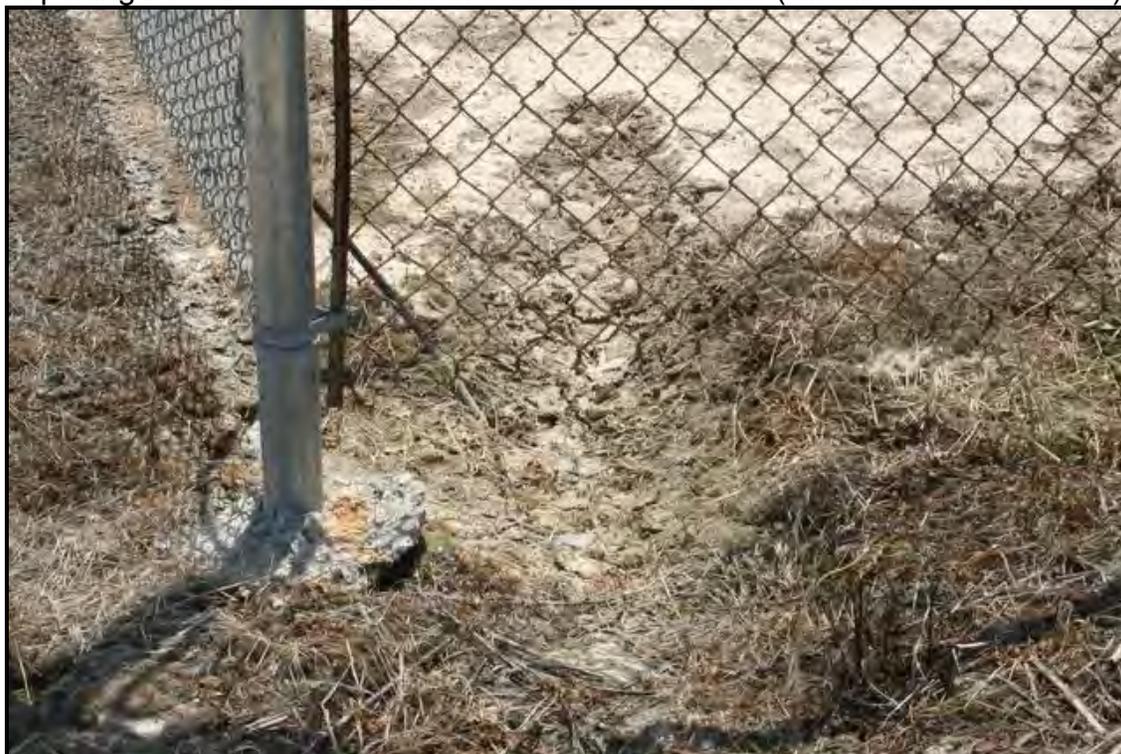
The most serious issue that Staff noticed during its inspection of this circuit involved wide openings underneath the South Division Street Substation perimeter fence. That substation is the source for Circuit 31000. The openings were in all directions and were so wide that a relatively large animal such as a coyote can get inside the substation. In addition to being a reliability threat, those openings are so wide that a person can use them to enter inside the substation, which poses a public safety hazard. Figure (21) is a depiction of those openings. Figure (22) shows a ground cable broken away from the substation fence in violation of NESC Rule 092.E.5, which requires that the grounding conductor be connected to the substation fence's post.

Figure (21)
Opening beneath South Division St. Substation fence (Circuit 31000-Photo 41)

During Staff's October circuit inspection, Staff visited the South Division Street substation to verify MCPU's remedial work on the substation fence that MCPU stated it has performed. Although MCPU has added another layer of wire netting to it, there are still openings beneath the substation fence. There are also openings on the gate of the substation. Grounding of the fence and the gates of the substation is still inadequate.

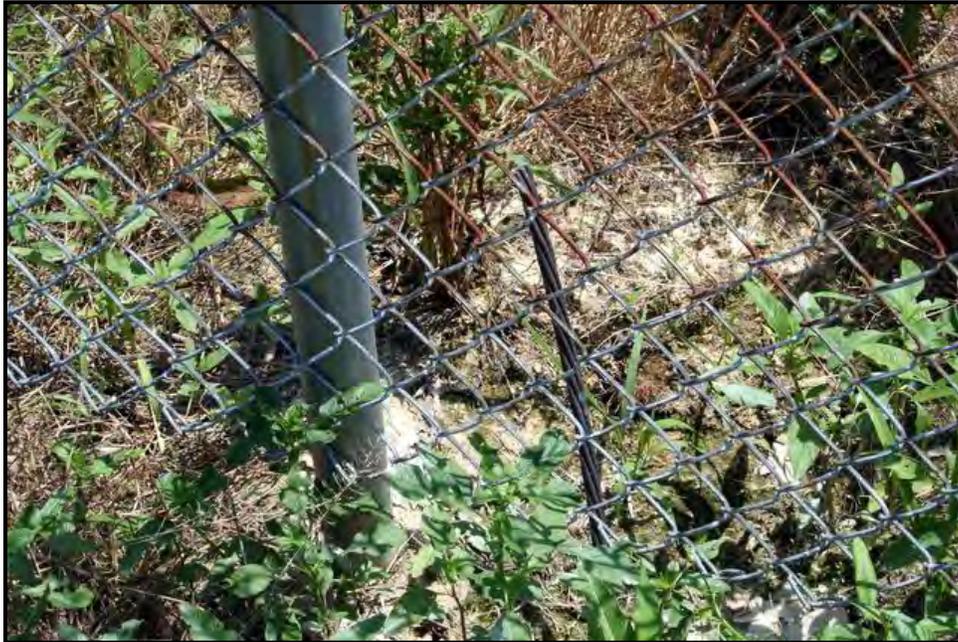
Figure (22)
Grounding wire disconnected from the post of
South Division St. Substation fence (Circuit 31000-Photo 40)

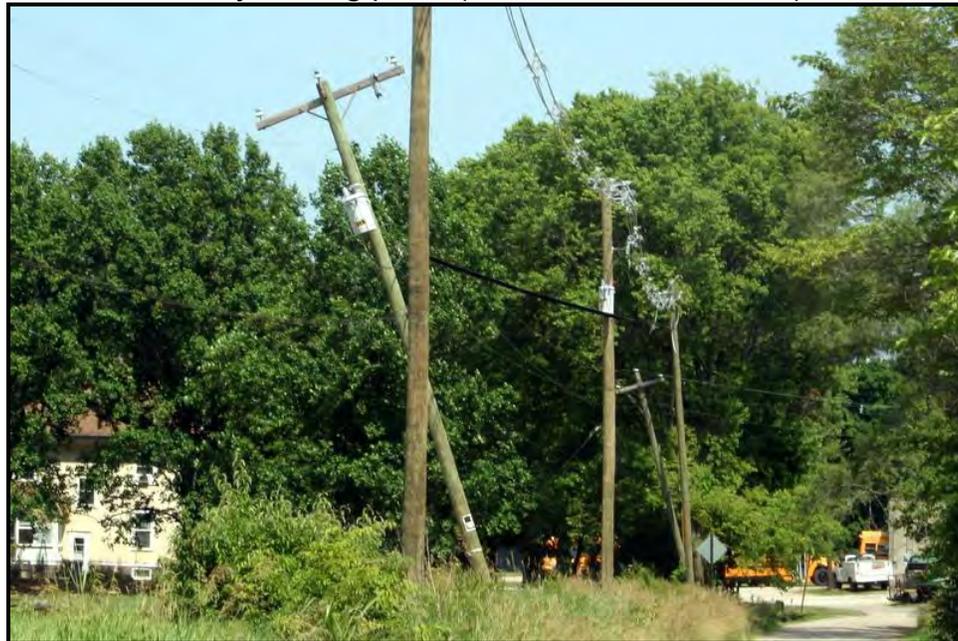
Staff found two instances of low primary wire clearance in violation of NESC Rule 234.C.1.a. Staff found badly leaning poles in two different locations. The more striking was a string of five poles on N. 1250 Boulevard, between West Third Street and Southern Railroad R.O.W. Figure (23) is a shot of two of those poles. Concerning this situation MCPU provided the following comment

Figure (23)
Badly leaning poles (Circuit 31000-Photo 45)

These poles have been placed in this position in accordance with utility industry standards to allow for installation of new and upgraded facilities in an effort to replace approx. 0.47 line miles of existing facilities from the West Third Street Substation location east to Line Section #31000 to provide suitable supply capability for portions of this circuit to be back-fed from this location. MCPU estimates that this project will be completed by early fall 2010.

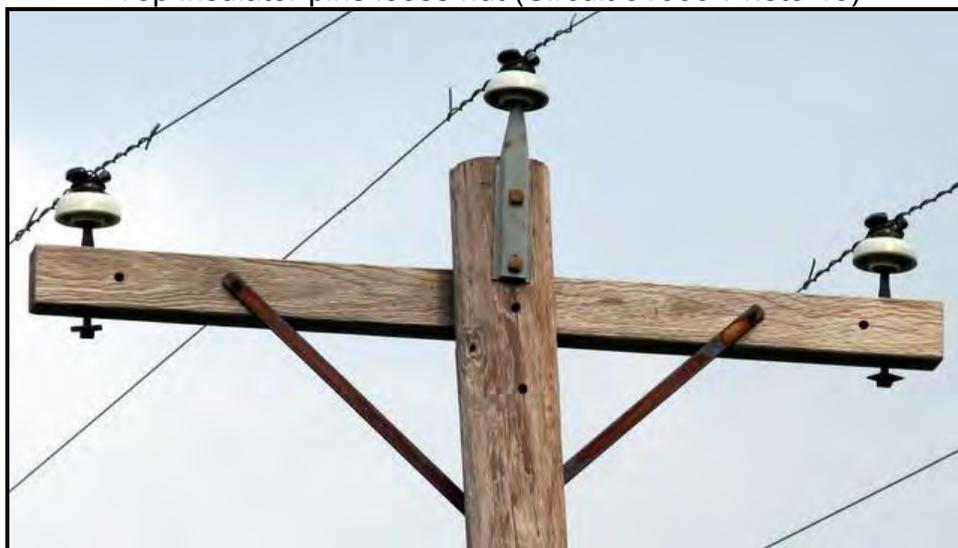
Figure (24)
Top insulator pins loose nut (Circuit 31000-Photo 46)

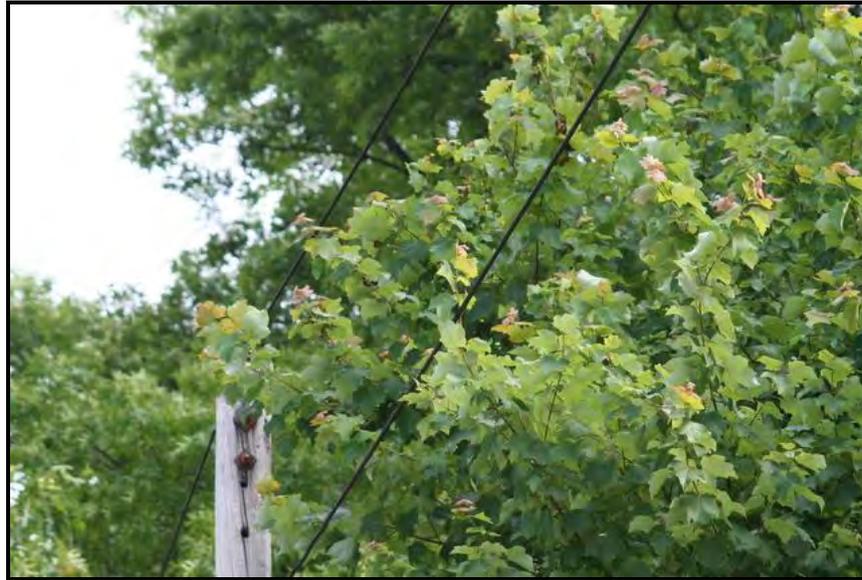
Figure (25)
Tree contacts primary wire (Circuit 16000-Photo 52)

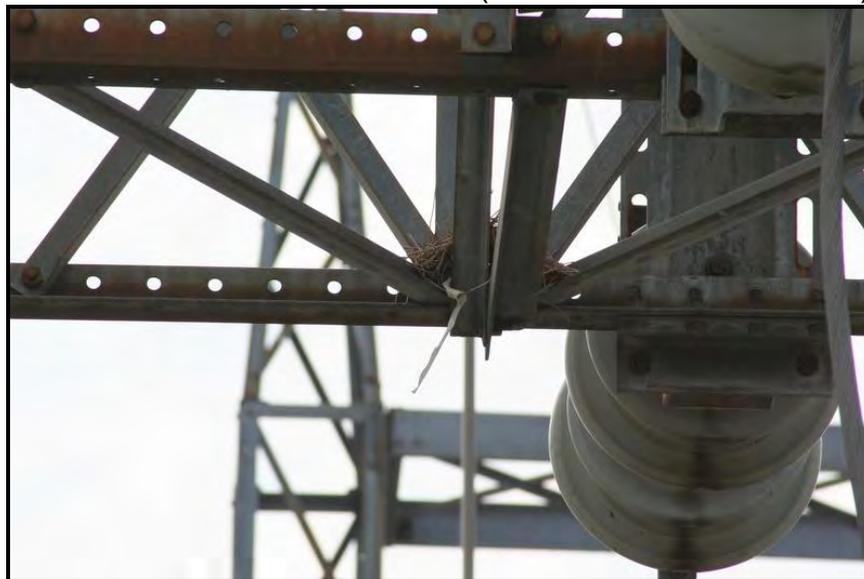
Figure (26)
Bird nest on substation structure (Plant Substation-Photo 47)

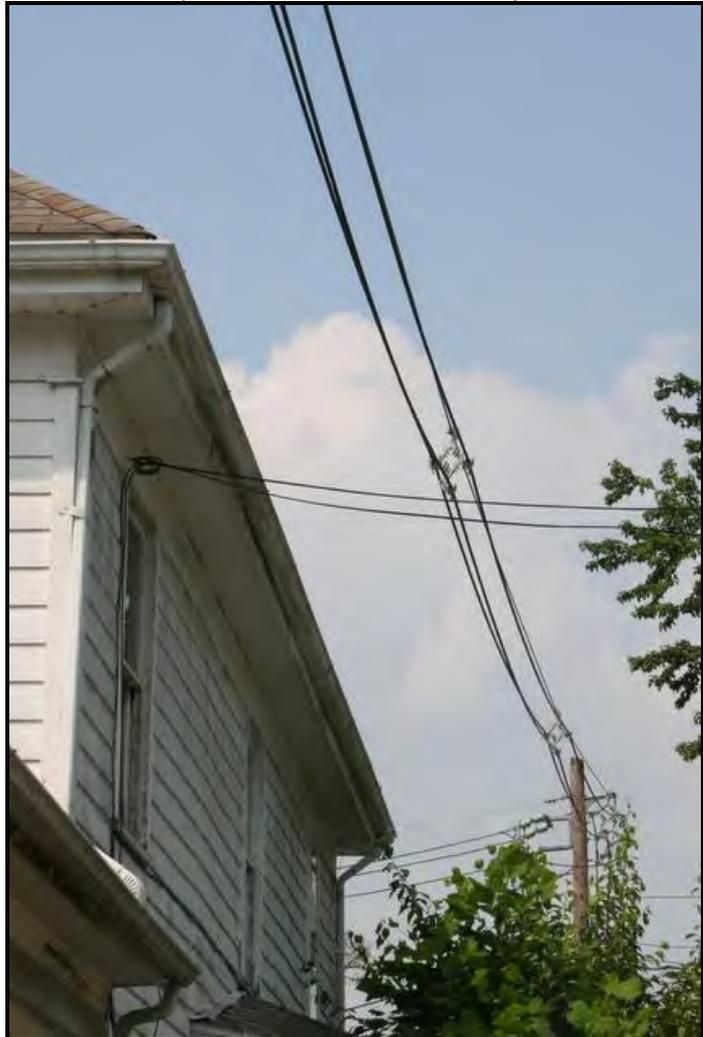
Circuit 12000, known as Circuit #2, serves 357 customers at 12,470 volts in a predominantly urban area within the city of Mt. Carmel. MCPU reported Circuit 12000 as next to worst performing circuit in 2009 and 2008. On June 11, 2010, Staff performed a field inspection on Circuit 12000. Staff recorded eighteen instances that might pose a reliability threat to this circuit. Fifteen of those instances involved trees conflicting with primary wires. NESC Rule 233.C.1 specifies the vertical clearance requirements between any crossing or adjacent wires, conductors, or cables carried on different supporting structures. Staff discovered a violation of this rule on an alley north of 614 Mulberry Street where the clearance between the circuit primary wires and a telecommunications cable did not meet the requirements of NESC Rule 233.C.1. The same electric cable has an inadequate clearance from the structure of house number 614 A Mulberry Street, which is a violation of NESC Rule 234.C.1.a. Figure (27) embodies both violations.

Figure (27)
Horizontal clearance violation
Vertical clearance violation
(Circuit 12000-Photo 57)

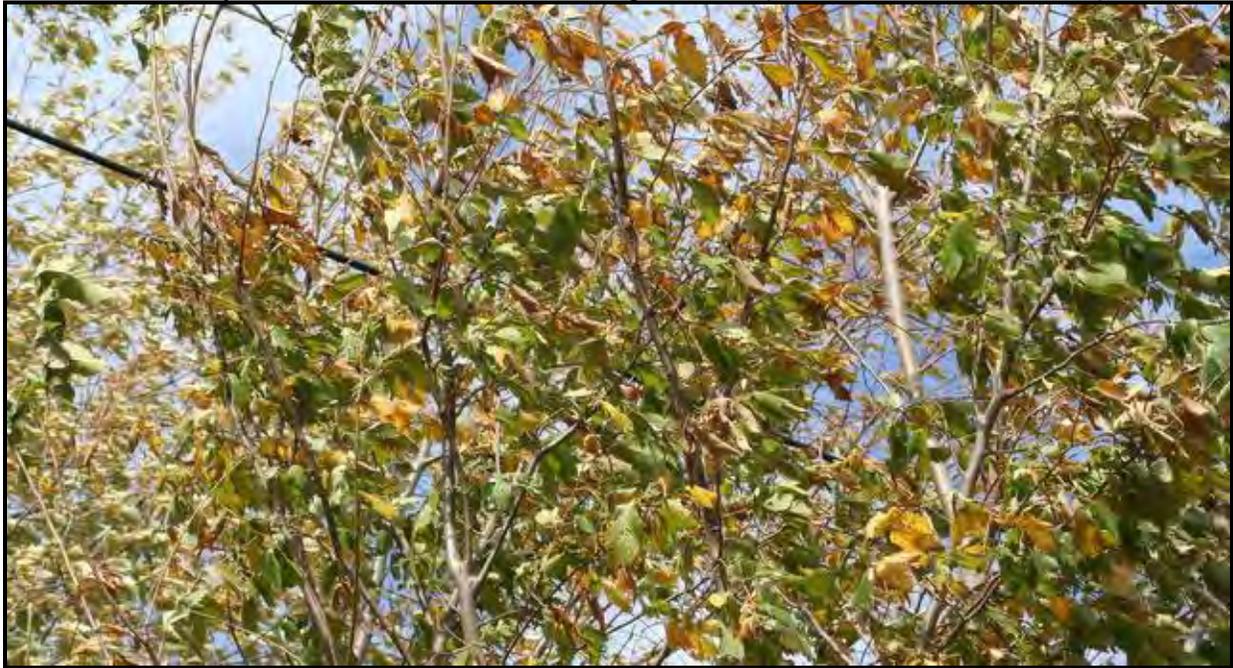
Primary and neutral wires run through a tree (Circuit 22000-Photo 66)

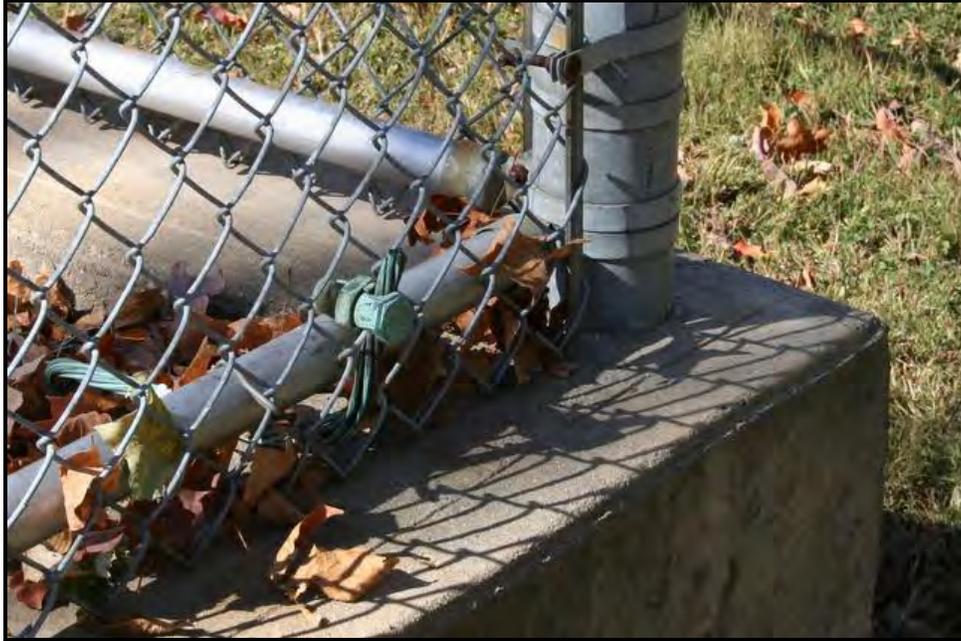
NESC Rule 092.E.5 requires that grounding conductor be connected to the substation fence's post. As shown in Figure (27), MCPU's practice is to connect ground wires to the wire netting rather than to the posts as required by NESC. MCPU has to alter its practices to conform with the NESC requirements. Staff also noticed that the gates of this substation are not grounded properly.

Figure (27)
Inadequate substation fence grounding (Circuit 22000-Photo 60)

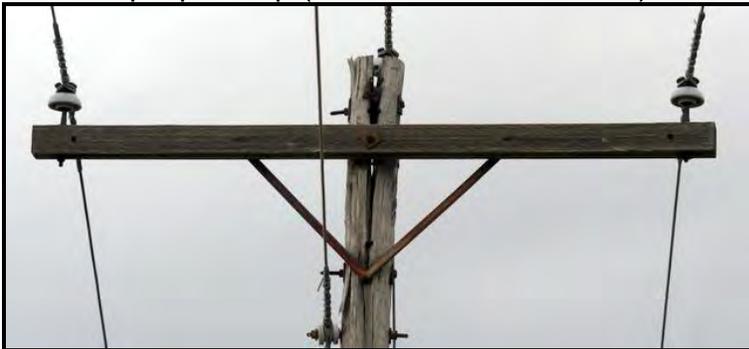
Figure (28)
Split pole top (Circuit 22000-Photo 74)

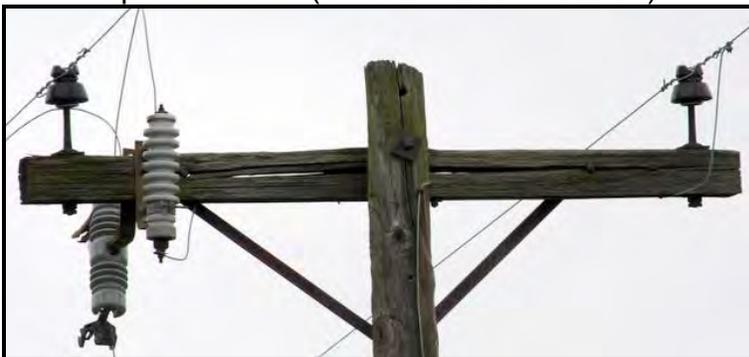
Figure (29)
Split crossarm (Circuit 22000-Photo 81)

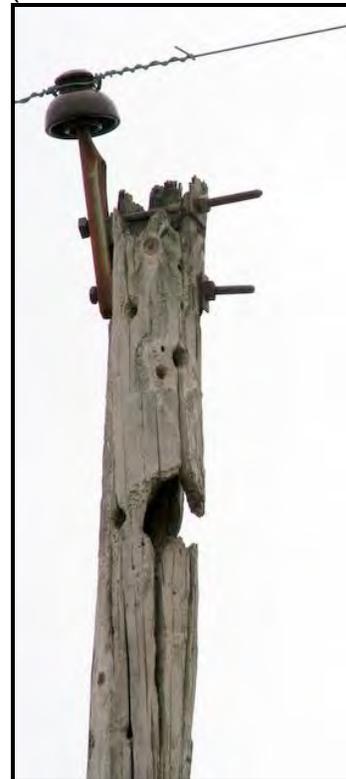
Figure (30)
Decayed pole top (Circuit 22000-Photo 84)
