Illinois Commerce Commission

Staff's Assessment Report of MidAmerican Energy Company 2010 Reliability Report

August 23, 2012

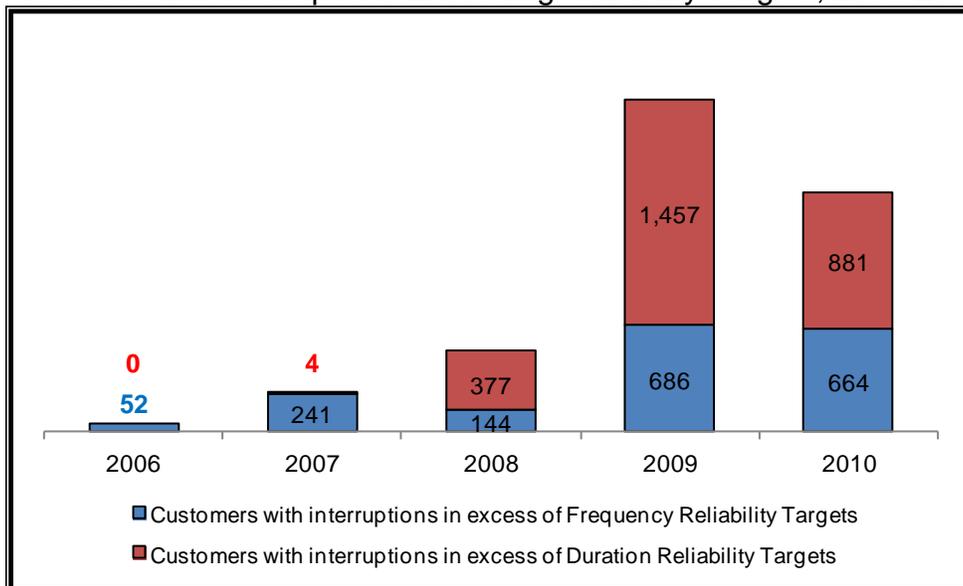
Figure (1)
Customers with Interruptions Exceeding Reliability Targets, 2006-2010

As shown in Figure (1), the number of customers experiencing interruptions exceeding the frequency target declined by 28% after it had been increasing steadily since 2006. The number of customers experiencing interruptions exceeding the duration target was

greater than the number of customers experiencing interruptions exceeding the frequency target for three consecutive years. In a supplement to its 2010 Reliability Report, MEC suggested that the reason for the spike in those numbers was the occurrence of multiple major storms in 2008, 2009, and 2010. MEC reported that the most significant major storm in 2008 was the “derecho”¹ that passed through MEC’s Illinois service territory on July 21, 2008, but did not comment on the nature or severity of the 2009 or 2010 storms. Since the targets apply only to customers experiencing service interruptions for three consecutive years, it means those customers consistently experienced annual service interruptions more than six times and/or that totaled more than eighteen hours a year since at least 2008. Although the weather could be a major factor of power outages, other factors might have kept the number of customers who experienced outages in excess of reliability targets at a high count. Examining information that MEC provided Staff in 2010 and the preceding years leads Staff to believe that extreme weather just highlighted the increased possibility for MEC’s customers to experience poor electric service during such weather conditions.

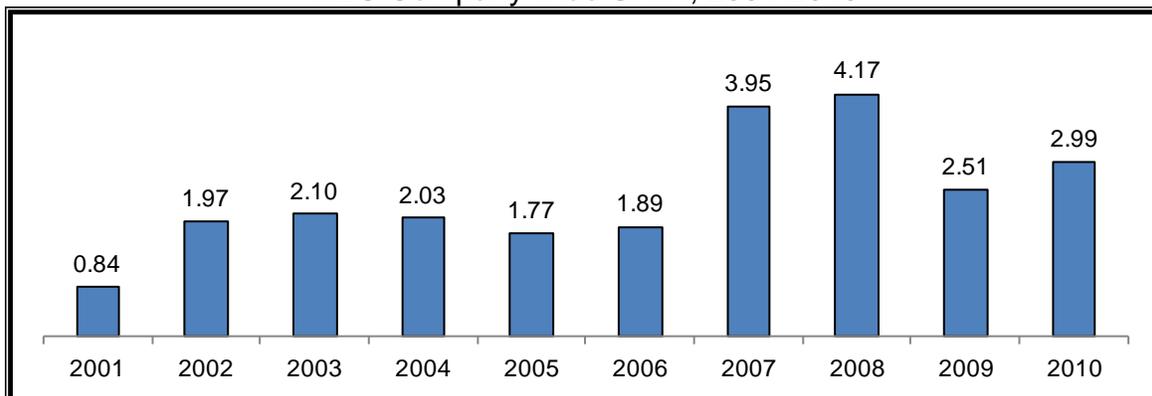
Figure (45)
MEC Company-wide SAIFI, 2001-2010

Figure (45) shows MEC's company-wide SAIFI values from 2001 to 2010. In 2010, SAIFI increased by 19% compared to 2009, which is the third worst company-wide SAIFI value MEC has reported in the past ten years and three and one-half times the lowest SAIFI MEC reported in the past ten years.

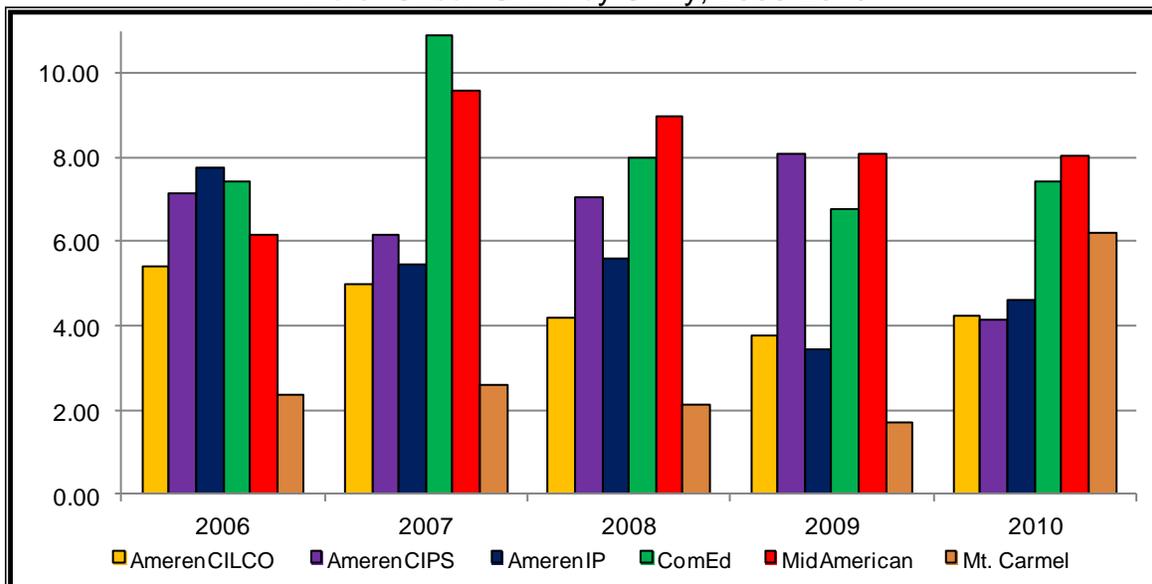
Figure (46)
Worst-Circuit SAIFI by Utility, 2006-2010

Figure (46) is a comparison of SAIFI values for each of Illinois public utilities' single worst performing circuit for the period from 2006 to 2010. In 2010, MEC's worst SAIFI performing circuit had the worst SAIFI among all Illinois public utilities' single worst SAIFI performing circuits. This is the third consecutive year in which MEC's worst SAIFI performing circuit records the highest SAIFI in Illinois.

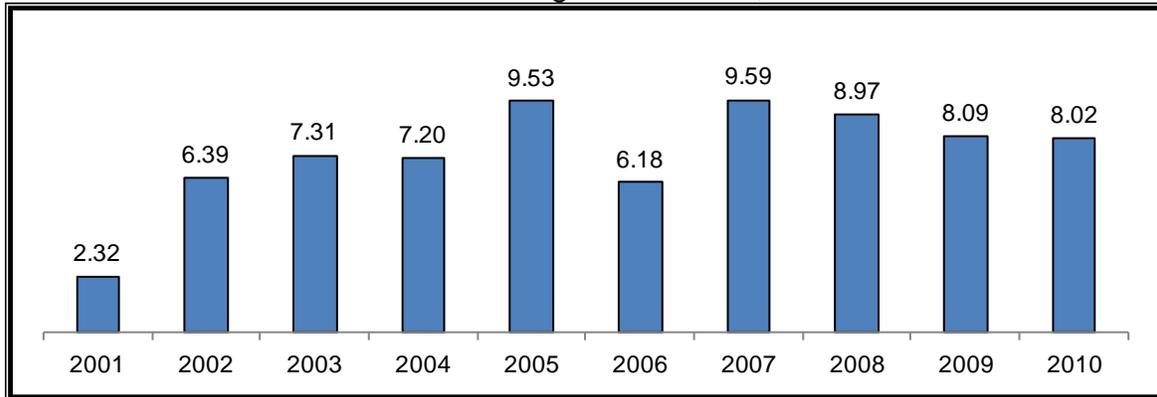
Figure (47)
MEC Worst Performing Circuit SAIFI, 2001-2010

Figure (47) shows MEC’s SAIFI values for worst SAIFI performing circuits from 2001 to 2010. SAIFI value for MEC’s worst SAIFI performing circuit has been declining since 2008; however, the value is still 9% above the average worst SAIFI in the past ten years.

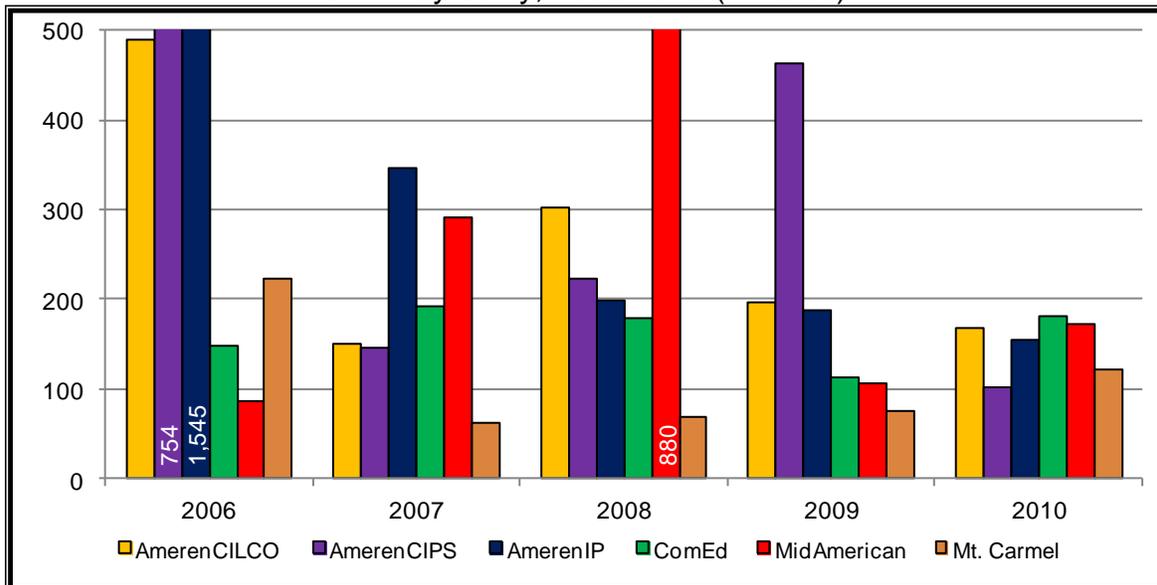
Figure (48)
CAIDI by Utility, 2006-2010 (minutes)

Figure (48) is a plot of company-wide CAIDI for all Illinois public utilities for the years 2006 to 2010. In 2010 MEC reported the second highest (second worst) CAIDI among Illinois public utilities, a 62% increase from MEC’s 2009 CAIDI, which was the second best CAIDI among Illinois utilities.

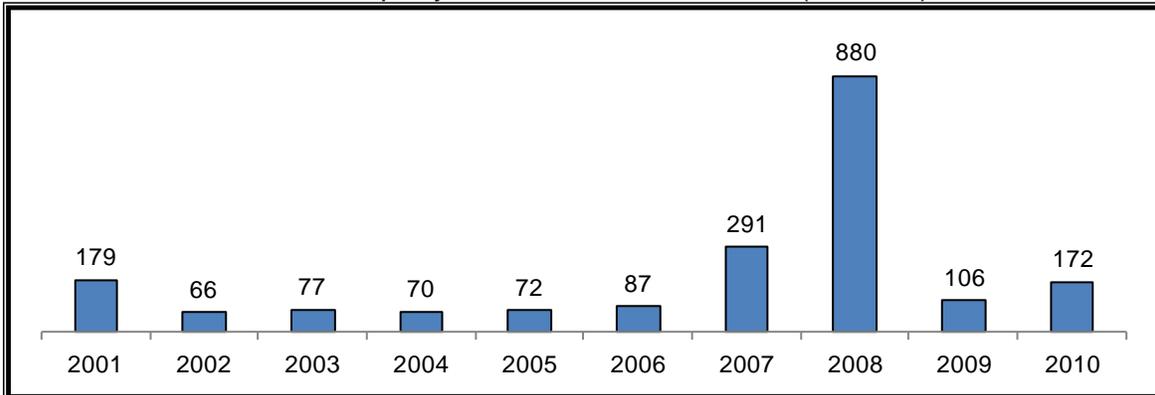
Figure(49)
MEC Company-wide CAIDI, 2001-2010 (minutes)

Figure (49) shows MEC’s company-wide CAIDI values from 2001 to 2010. MEC’s company-wide CAIDI deteriorated with a 62% increase from 2009 to 2010 and the fourth worst CAIDI that MEC reported in the last ten years.

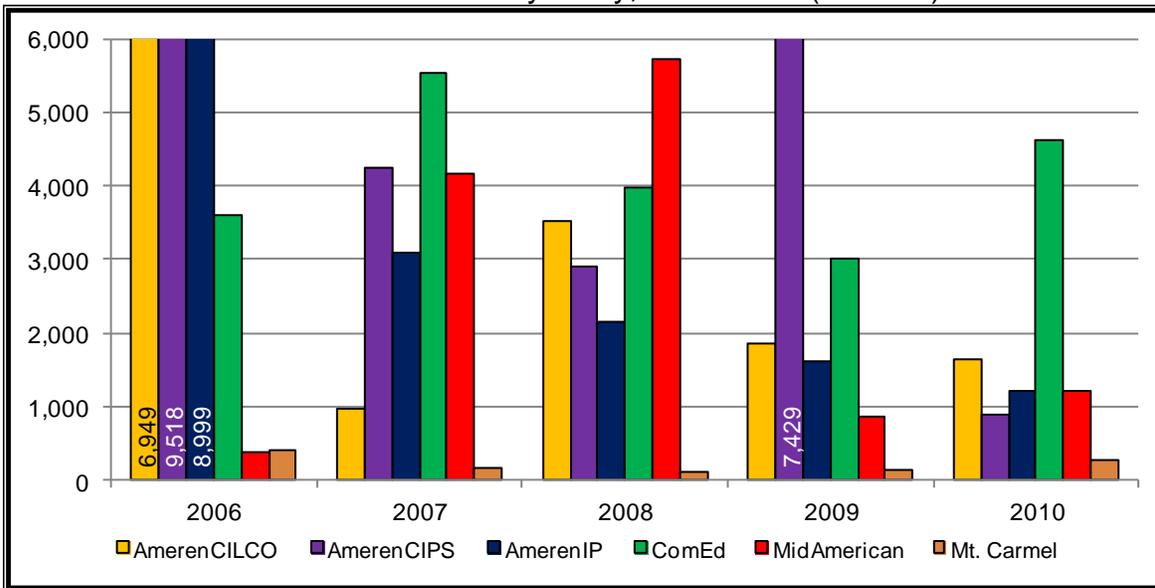
Figure (50)
Worst-Circuit CAIDI by Utility, 2006-2010 (minutes)

Figure (50) is a comparison of CAIDI values for each of Illinois public utilities' single worst performing circuit for the period from 2006 to 2010. MEC's worst CAIDI performing circuit for 2010 ranked in the middle among all Illinois public utilities' single worst CAIDI performing circuits while in 2009, MEC's worst CAIDI performing circuit recorded the second lowest CAIDI value among Illinois public utilities' single worst CAIDI performing circuits.

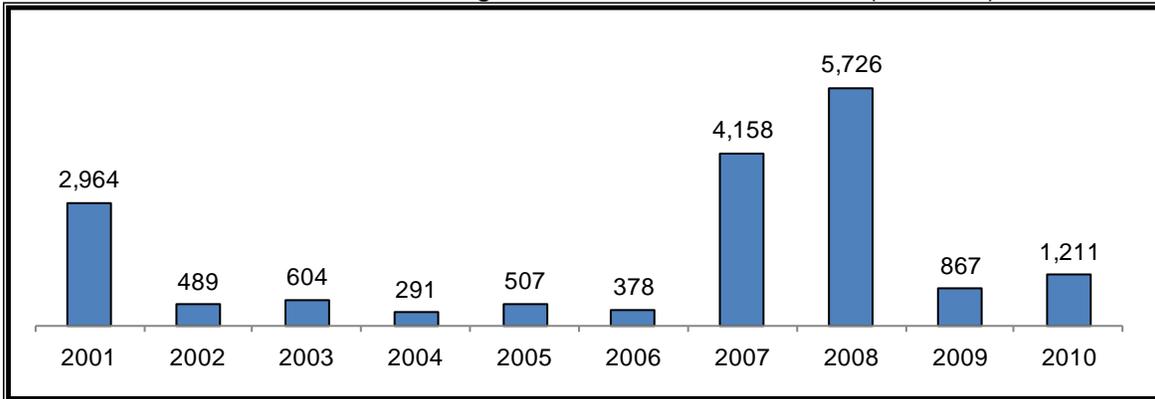
Figure (51)
MEC Worst Performing Circuit CAIDI, 2001-2010 (minutes)

Figure (51) shows the CAIDI values for MEC's worst-performing CAIDI circuits from 2001 to 2010. In 2010, MEC's CAIDI number deteriorated by nearly 40% compared to 2009 and ranks fourth among MEC's worst-CAIDI performing circuits' since 2001.

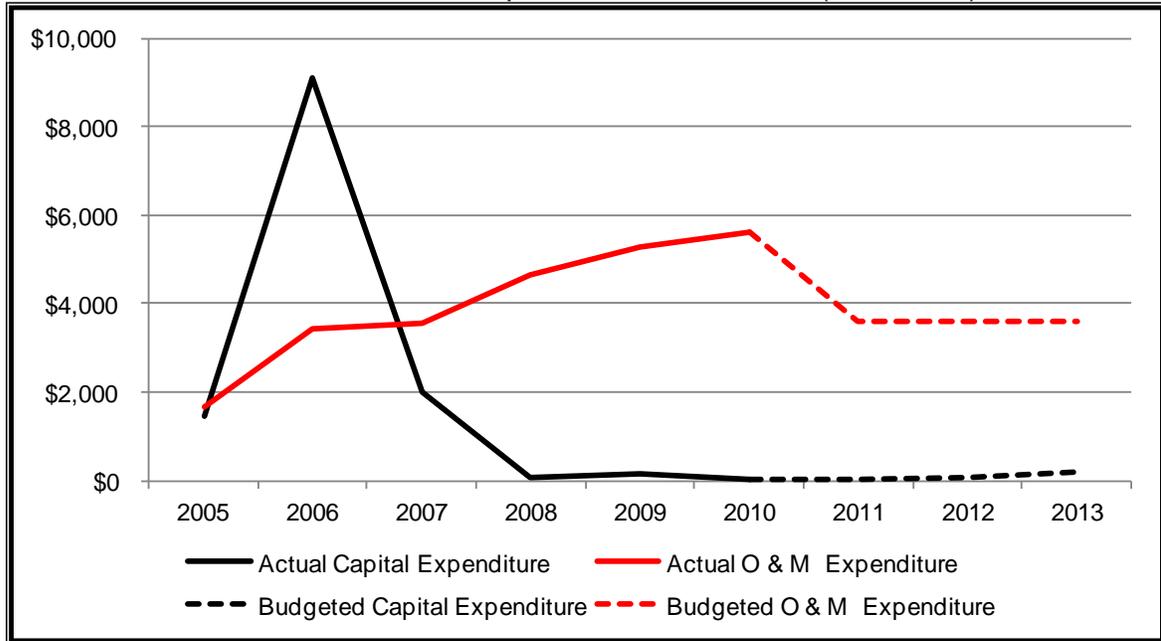
Figure (53)
MEC Transmission Expenditure, 2005-2013 (thousands)

Figure (53) is a graphical representation of MEC historical and future transmission expenditures. MEC dramatically decreased its transmission capital expenditures from \$310 thousand in 2004 to \$21 thousand in 2010. Since it peaked in 2006, MEC's transmission capital expenditures followed a sharp declining trend. MEC plans to increase its spending on transmission capital projects steadily from 2011 through 2013.

In 2008, 2009, and 2010, MEC spent an average of 1.4% of its overall transmission expenditures on capital projects but plans to spend an average of 2.4% of its overall transmission budget on capital projects in 2011, 2012, and 2013. Staff is concerned with the MEC's continuing trend of spending disproportionately far less money on transmission capital projects compared to transmission O&M expenditures. MEC has to provide an explanation for the highly disproportionate ratio between its capital spending and its O&M spending.

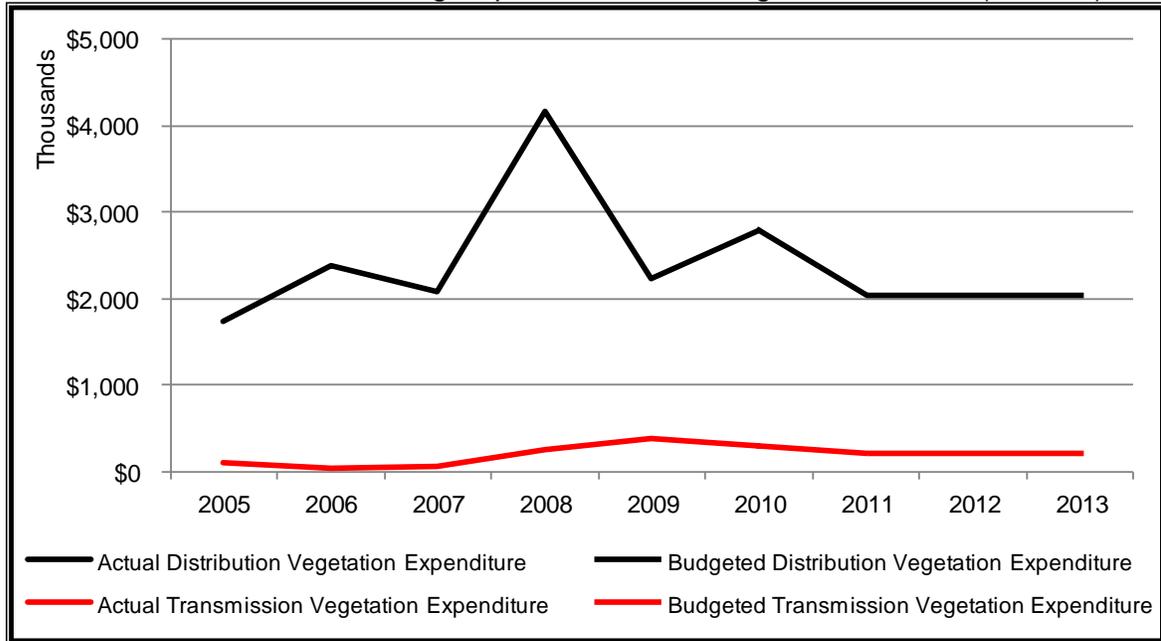
Figure (54)

In 2010, MEC spending on its distribution tree trimming programs increased by 25.9% from its 2009 level, but MEC plans to decrease its distribution tree trimming expenditure in 2011 by approximately 26.8% compared to 2010. MEC plans to spend the same dollars (approximately \$2.0 million per year) in each of the following three years, which is less than what MEC spent in each of the previous five years. Staff questioned MEC about the reasons of lowering the distribution tree trimming budget for each of the next three years. In response to Staff's inquiry, MEC stated, "[the] primary reason annual distribution vegetation management budgeted expenditures for 2011 – 2013 are lower than the actual distribution vegetation management expenditure for 2010 is primarily due to unbudgeted storm restoration expenditures in 2010 and slightly reduced anticipated work load in 2011." Given the vegetation situation that Staff observed during its circuit inspections, MEC's plan to reduce tree trimming expenditure in the next three years raises Staff's concerns about MEC's vegetation management and its effects on its distribution system reliability in the future.

In 2010, MEC decreased its transmission tree trimming expenditures by 20.2% compared to 2009. MEC expects to decrease its transmission vegetation expenditures by 29.7% in 2011 and then increase it slightly in 2012 and 2013. Staff is concerned that MEC spends less in its transmission tree trimming program. As notes earlier in this report, Staff observed tree conflict with a 69 kV line feeding Substation 107. Staff believes that reducing transmission tree trimming budget would result in situations similar to the one that Staff documented in Figure (4). Staff remains concerned about the effects low vegetation management budget will have on MEC's overall system reliability.

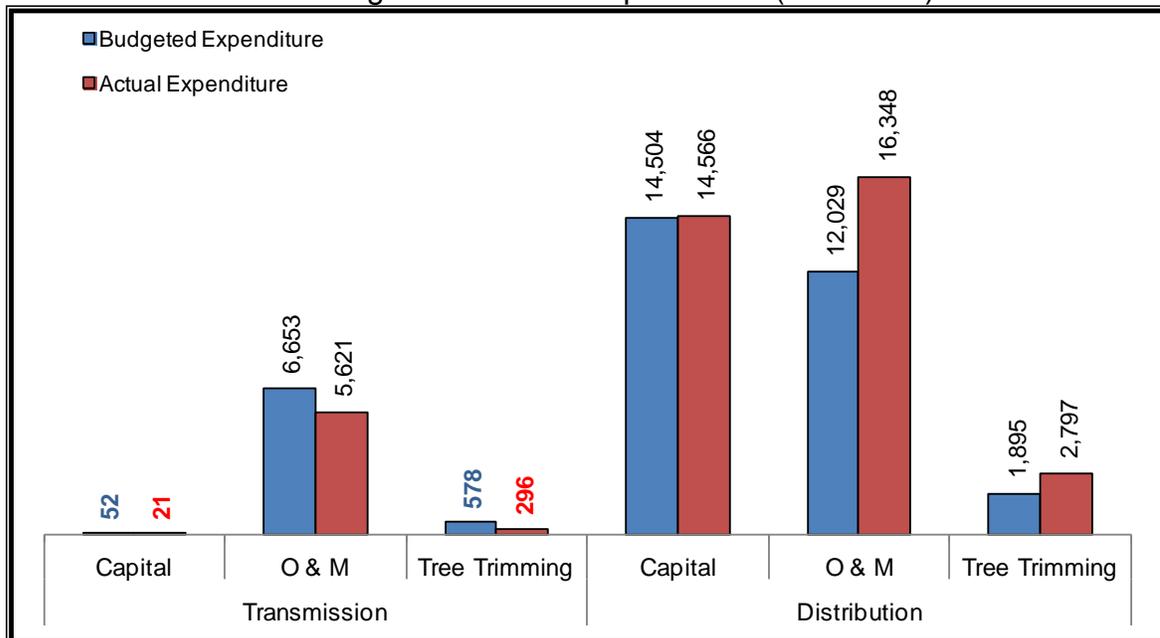
Figure (55)
2010 Budgeted Vs Actual Expenditures (thousands)

In 2010, MEC's transmission capital, O&M, and tree trimming expenditures went under-budget. On the other hand, in 2010, MEC's distribution capital, O&M, and tree trimming expenditures went over-budget. The most noticeable deviations occurred on the distribution O&M and tree trimming expenditures where MEC deviated from its last year's projections by 36% and 48% respectively.
