Response to 83 Illinois Administrative Code
411 – 2005 Annual Report
Revised July 21, 2006

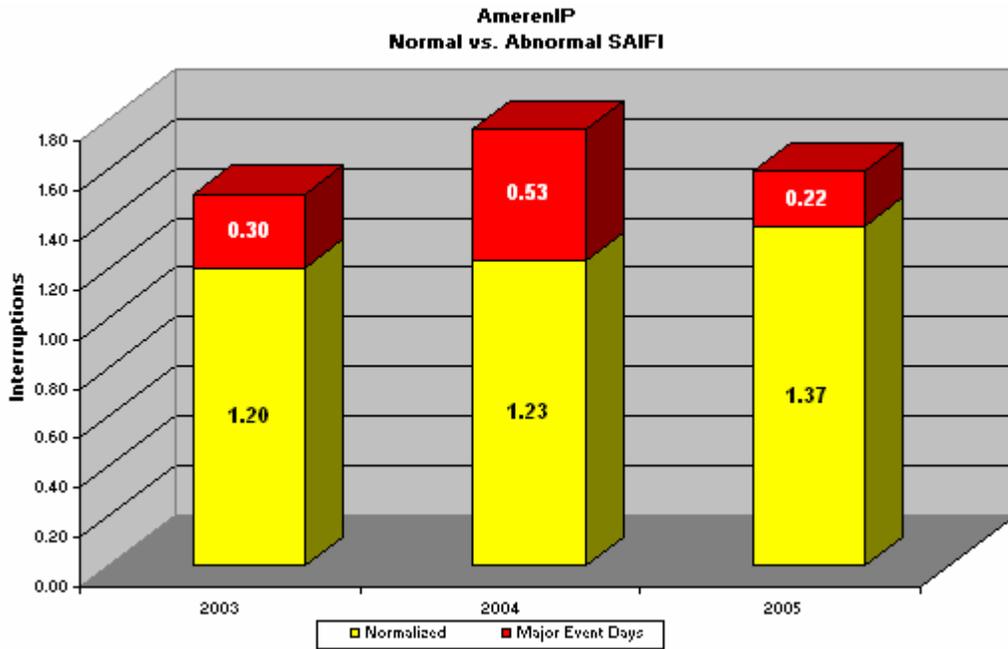
Figure 1 Normalized SAIFI Data

AmerenIP's System Average Interruption Frequency Index ("SAIFI") and Customer Average Interruption Duration Index ("CAIDI") demonstrate the significant impact of outages from the days in 2005 that were MED's, as seen in Figure 1 and Figure 2. The majority of these MED's were due to weather events.

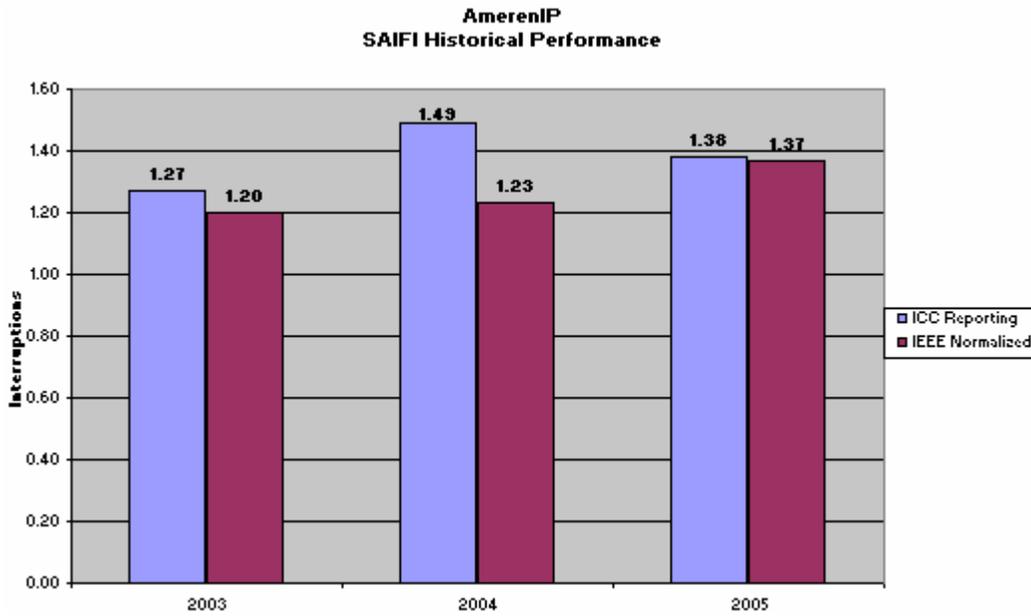
Figure 3 SAIFI Historical Performance

Figure 3 and Figure 4 compare AmerenIP's SAIFI and CAIDI historical performance using both ICC criteria and IEEE criteria.

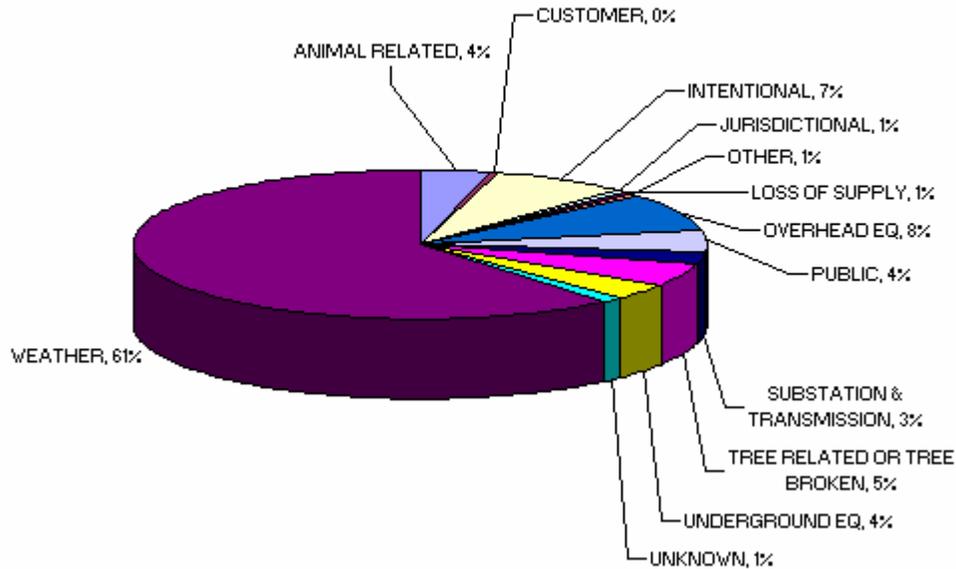
Figure 5 All Events by Duration

For simplicity of reading, some cause codes were combined. Public includes vehicles, vandalism, accident by others, dig-in by others and fires. Customer includes problems experienced on the customer's side of the meter. Weather-related outages include events such as tornados, floods, winds, excessive heat and cold, and ice storms.

The breakdown of CMI and CI is provided in Figure 5 and Figure 6.

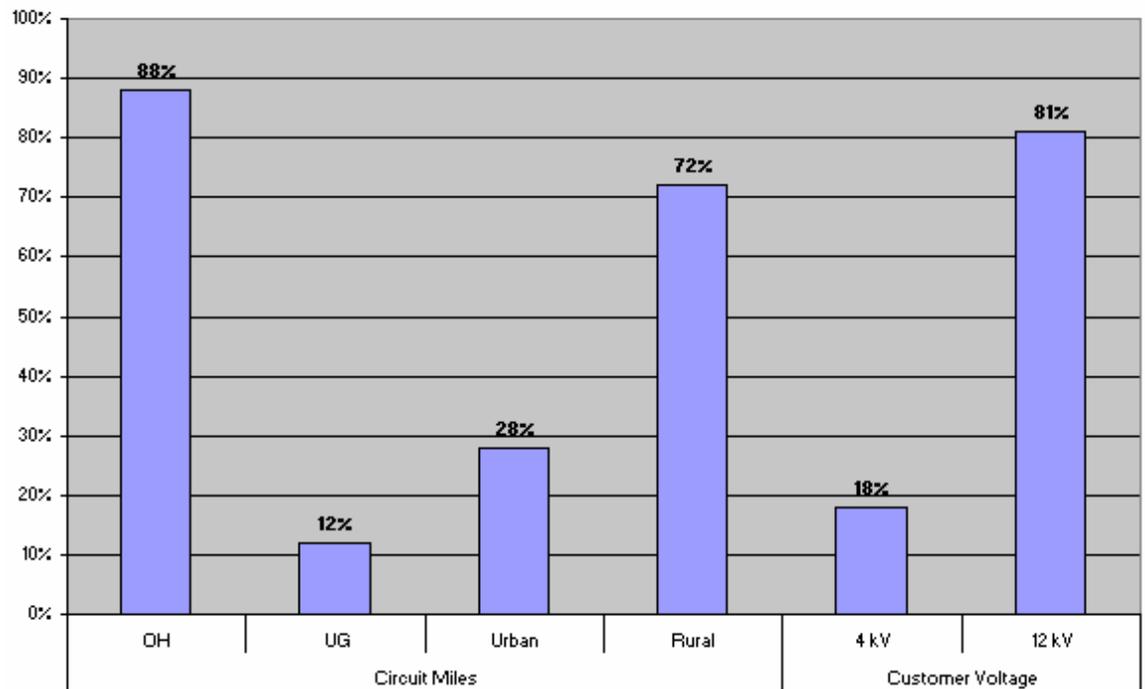
Figure 8 Characterization of AmerenIP's Distribution

Classification of circuits as urban or rural is based on the customer density per line mile. Circuits with fewer than 35 customers per line mile are classified as rural. All others are classified as urban. This breakdown is shown in Figure 8.

This figure also provides insight into the breakdown of line miles by overhead vs. underground and customers served at 4 kV vs. 12 kV.

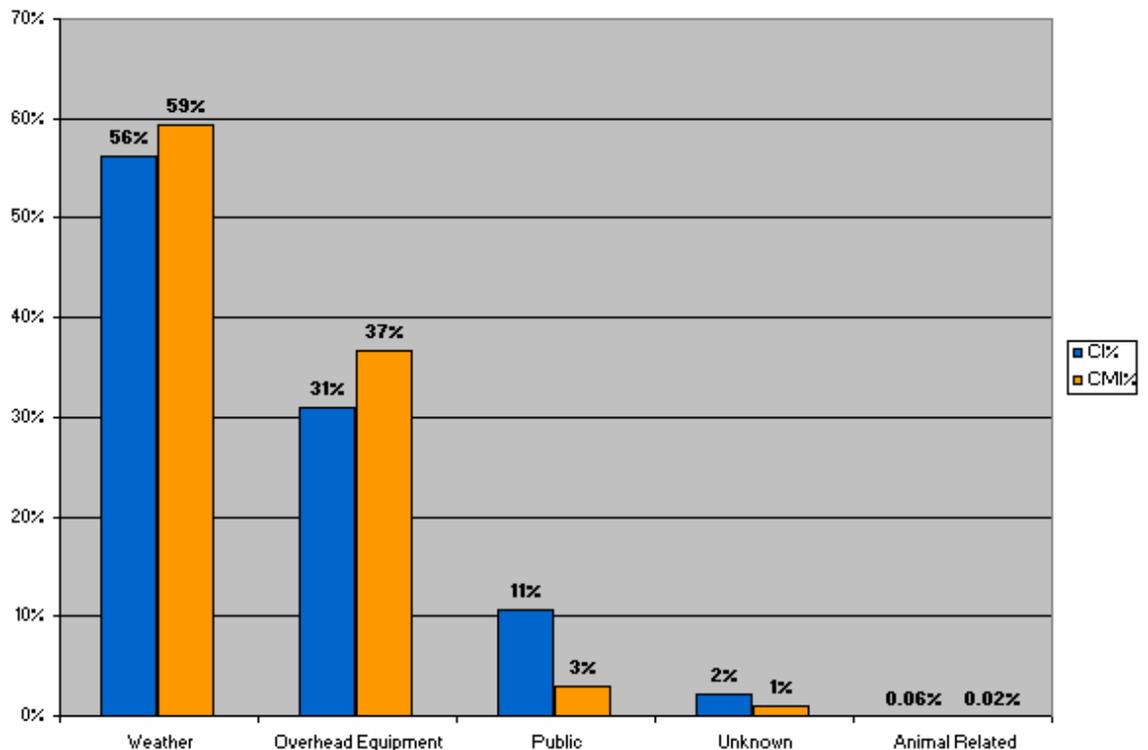
Figure 20 - 2005 WPC - H10843 – Witt, Irving - by Cause

This circuit was a worst performer from a CAIFI perspective. It is a rural 12 kV circuit that serves 1,164 customers. Figure 20 shows the percentage of CI and CMI by cause code for 2005.

Weather and overhead equipment-related outages were the major contributors for this circuit becoming a worst performer. In the spring of 2006, AmerenIP contracted with a pole inspection expert to perform an assessment of this circuit. More than 3,000 poles were tested on this 117-mile circuit. As a result, many poles will be replaced and some will be restored. Several crossarms, braces, and hardware issues will also be addressed. All work plans will be implemented by December 2006. This work will be completed at an estimated cost of \$150,000. Additionally, AmerenIP engineering will assess preliminary findings on decayed or split pole tops and leaning poles to determine if current conditions warrant additional work at this time. Two potential NESC violations found during the March 2006 ICC inspection have been reviewed by engineering. Corrective work plans are currently in progress.

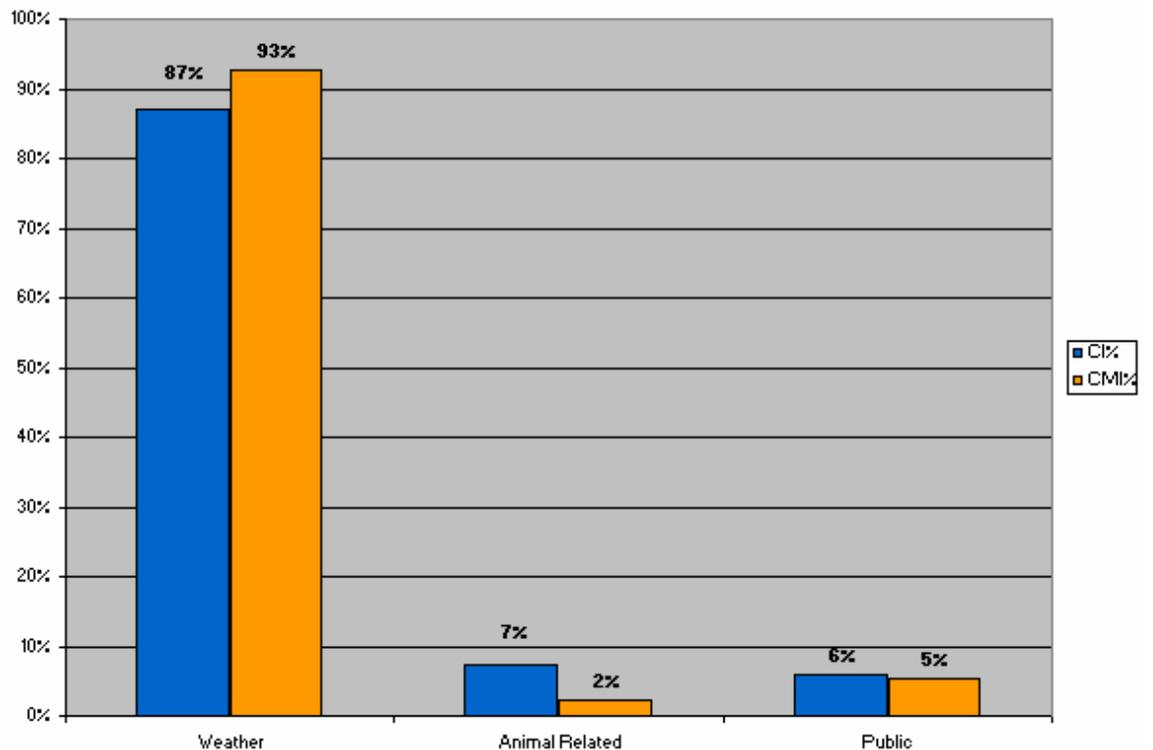
Figure 21 - 2005 WPC – J71129 - Sciota, Good Hope by Cause

This circuit was a worst performer from a CAIFI perspective. It is a rural 12 kV circuit that serves 391 customers. Figure 21 shows the percentage of CI and CMI by cause code for 2005.

A circuit inspection of this circuit was completed in the spring of 2006. Corrective work plans include removing several coiled stingers, installing animal protection at 131 locations, installing a few additional lightning arresters, replacing missing or loose hardware, replacing 5 old poles and installing 3 additional poles. This work is expected to cost approximately \$35,000 and will be completed by the end of 2006.

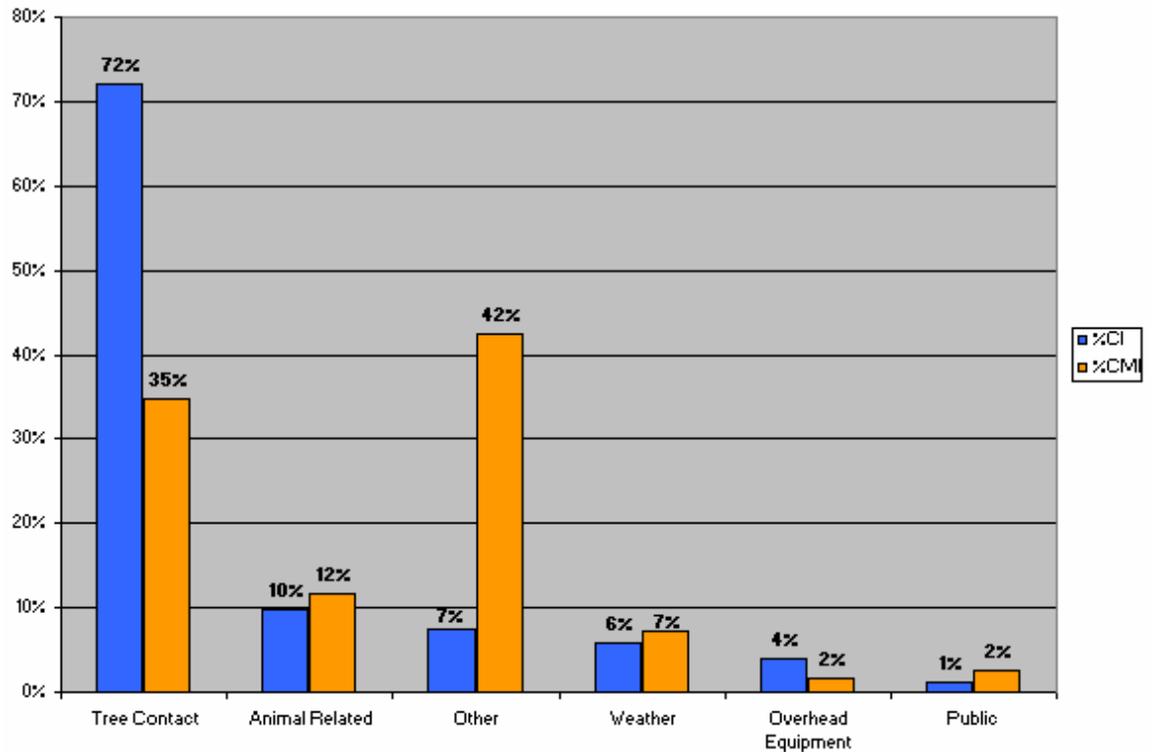
Figure 22 - 2005 WPC - J83139 - Belleville - by Cause

This circuit was a worst performer from a SAIFI perspective. It is a 12 kV urban circuit that serves 634 customers. Figure 22 shows the percentage of CI and CMI by cause code for 2005.

This circuit was trimmed in its entirety during the last quarter of 2005. A portion of this circuit experienced multiple outages. This portion is being reviewed for proper lightning and animal protection. Work plans will be developed accordingly and implemented prior to the end of 2006. Estimated expenditures are approximately \$5,000.

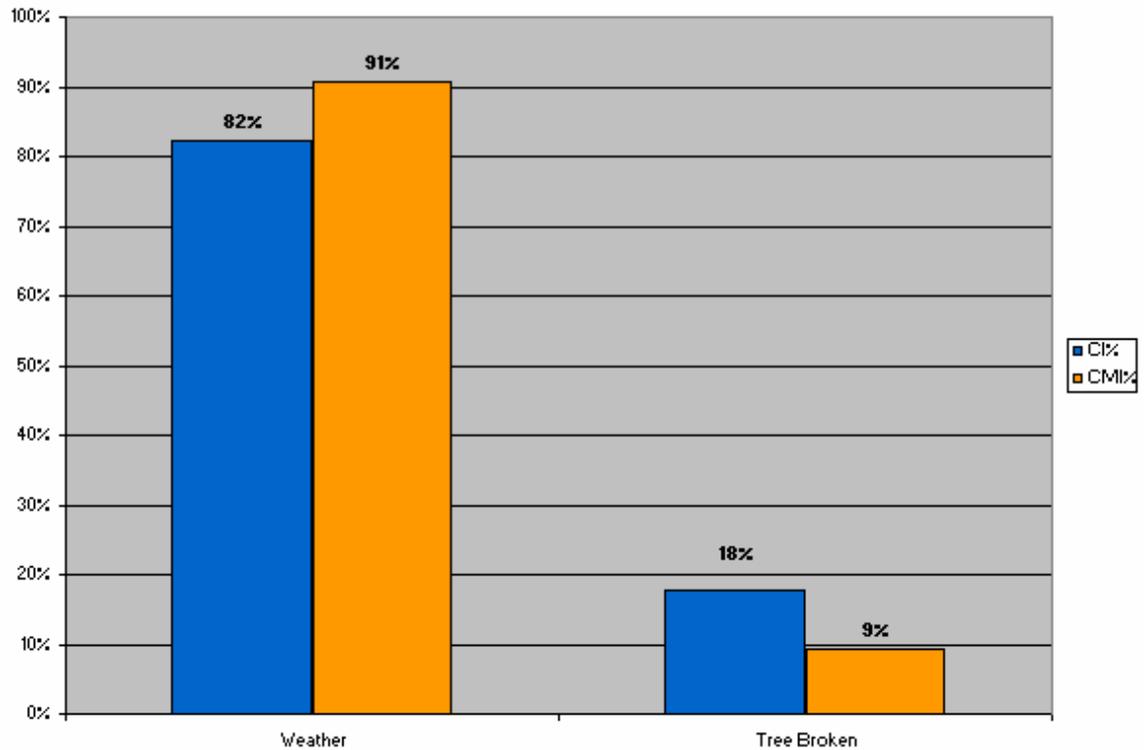
Figure 23 - 2005 WPC - J84124 - Belleville by Cause

This circuit was a worst performer from both SAIFI and CAIFI perspectives. It is a 12 kV urban circuit that serves 1,062 customers. Figure 23 shows the percentage of CI and CMI by cause code for 2005.

This circuit was again impacted by weather in 2005, causing it to be a repeat worst performer. Several work actions were completed in 2005 as a result of the Osrose inspection performed earlier in the year. A priority pole was replaced in June 2005, seventeen poles were reinforced with C-truss in September 2005, and a complete circuit-wide trim was completed in August last year. A patrol was also performed in the late summer of 2005 and several maintenance items, including lightning arrester replacement, were completed in early 2006 at a cost of \$7,000. The Company is currently working on replacing a buck pole and addressing an identified tree issue at an approximate cost of \$5,000; this work will be completed by July 2006.

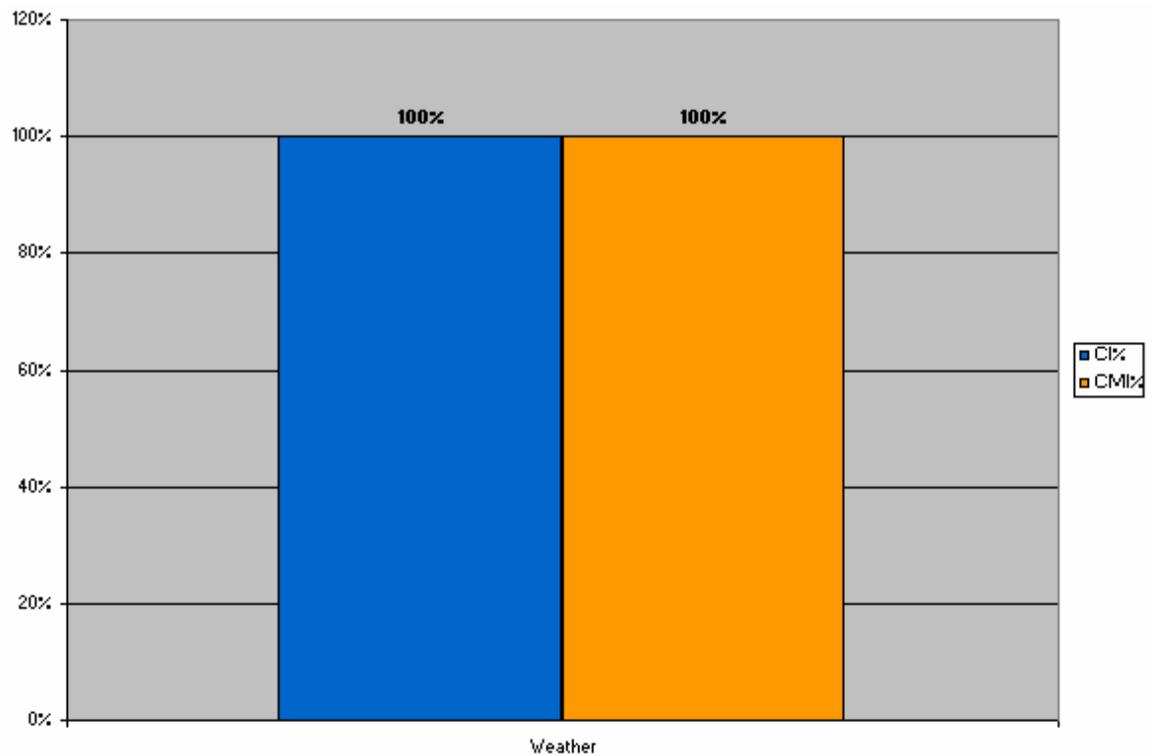
Figure 24 - 2005 WPC - J87101 - Belleville by Cause

This circuit was a worst performer from a CAIDI perspective. It is a 4 kV urban circuit that serves 244 customers. Figure 24 shows the percentage of CI and CMI by cause code for 2005.

Two extended outages that rolled to two separate fuses on July 4, 2005 caused this circuit to become a worst performer. The duration of the outages was extended due to the severity of the storm as crew resources were distributed throughout the metro area. Corrections were made to damaged facilities at the time of the outage.

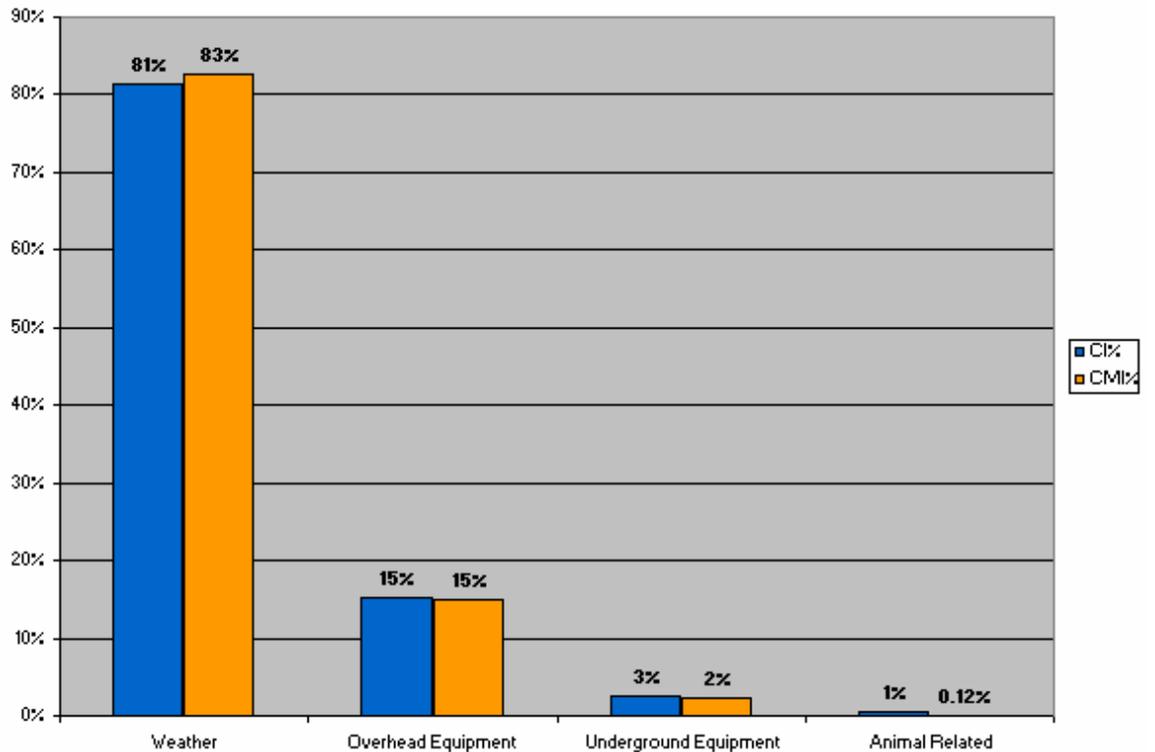
Figure 25 - 2005 WPC - J88165 - Belleville by Cause

This circuit was a worst performer from a SAIFI perspective. It is a 12 kV urban circuit that serves 920 customers. Figure 25 shows the percentage of CI and CMI by cause code for 2005.

The vast majority of outages occurred on this circuit during significant storms over the 4th of July holiday. According to IEEE methodology, July 4, 2005 is excluded as a major event day due to the severe storm and wide-spread damage. Facilities were repaired at the time of the damage. This circuit will undergo a mid-cycle trim in May of 2006 and a complete circuit-wide trim in late 2007. AmerenIP is currently in the process of performing a circuit coordination study on this circuit, with any work plans to be implemented by the end of 2006. Projected costs are approximately \$2,000.

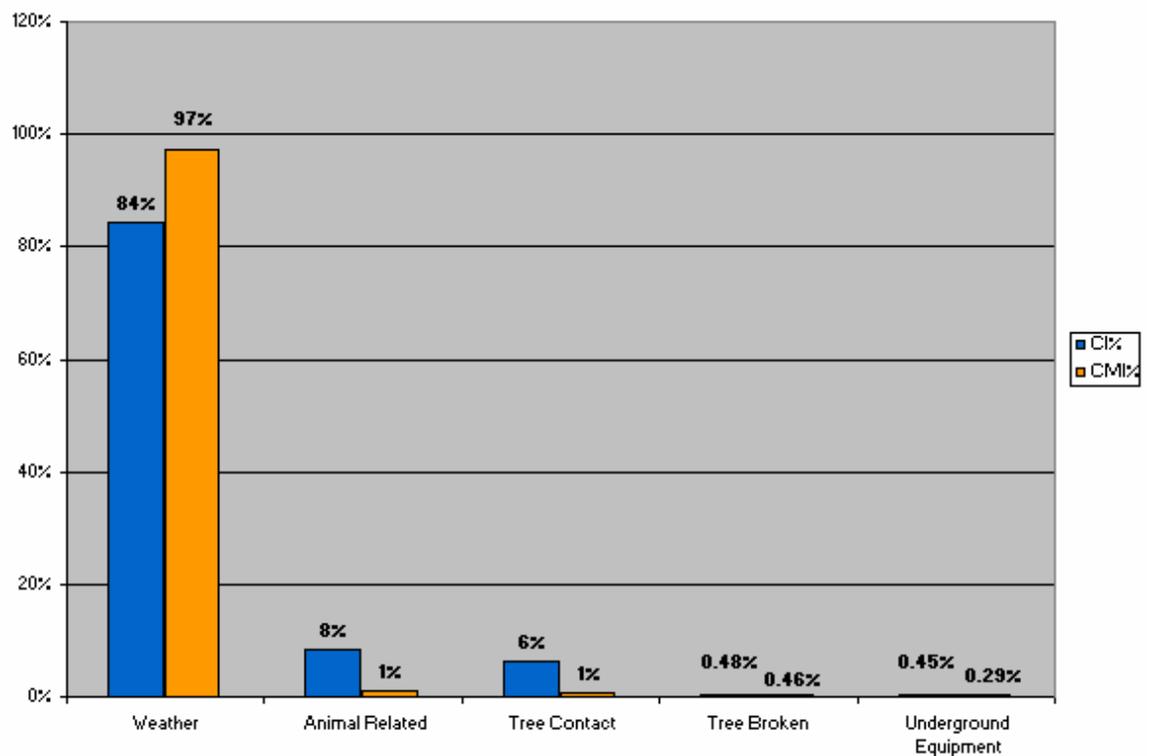
Figure 26 - 2005 WPC - K15205 - Centerville by Cause

This circuit was a worst performer from a CAIFI perspective. It is a 12 kV urban circuit that serves 1,322 customers. Figure 26 shows the percentage of CI and CMI by cause code for 2005.

The majority of outages on this circuit occurred during major storms over a several day period in August 2005. All damaged facilities were corrected at the time of the outages. In October 2005, the circuit was trimmed in its entirety.

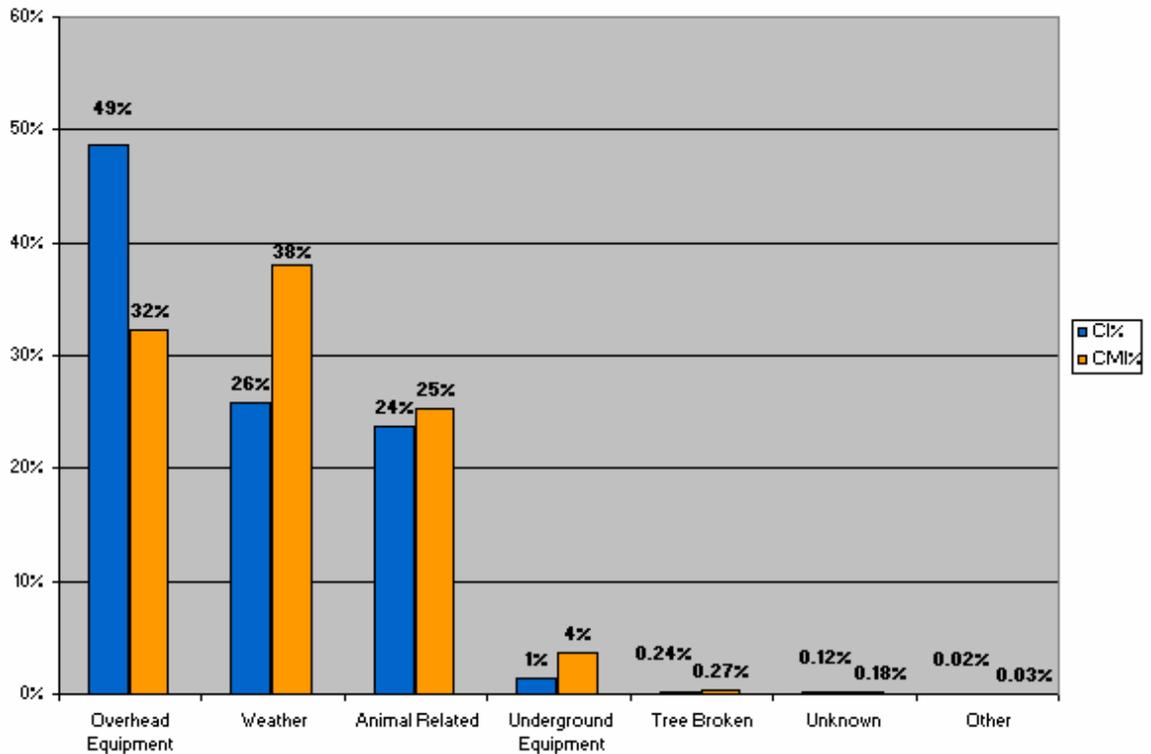
Figure 27 - 2005 WPC - K32915 - Chester by Cause

This circuit was a worst performer from a SAIFI perspective. It is a 12 kV urban circuit that serves 1,021 customers. Figure 27 shows the percentage of CI and CMI by cause code for 2005.

Several projects have been completed on this circuit over the past couple of years. In 2004, more than 50 locations were retrofitted with animal guards and insulated stingers. A disconnect switch was replaced and redesigned to eliminate outages caused by birds hanging on it. This work was completed in December 2005. A total of nineteen poles were replaced between the second half of 2005 and April 2006. This work was completed at a cost of approximately \$120,000. The last circuit-wide trim was completed in late 2004.

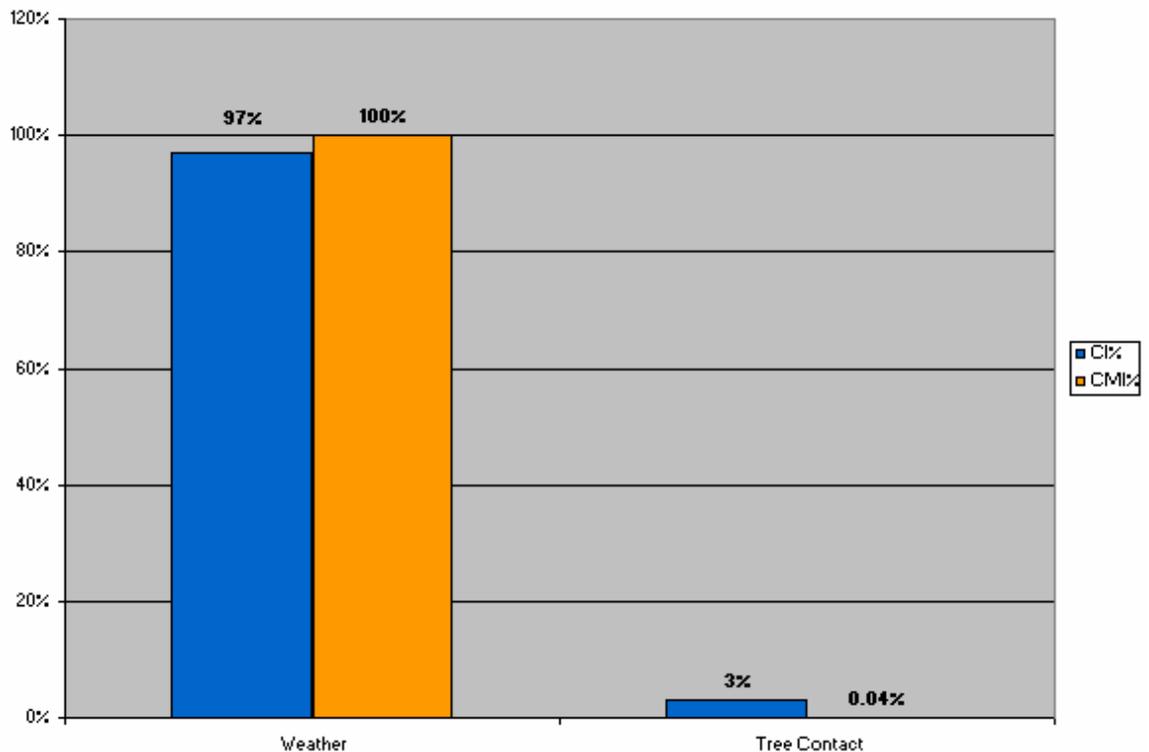
Figure 28 - 2005 WPC - K95203 - Decatur by Cause

This circuit was a worst performer from a CAIDI perspective. It is a 4 kV urban circuit that serves 514 customers. Figure 28 shows the percentage of CI and CMI by cause code for 2005.

Virtually the entire number of customer minutes of interruption occurred during the severe wind storm of June 13, 2005. All damage to the portions of the circuit affected was repaired in conjunction with storm work. The circuit will be inspected the second quarter of 2006. Any maintenance work as a result of the patrol will be completed. Cost estimates are not available at this time.

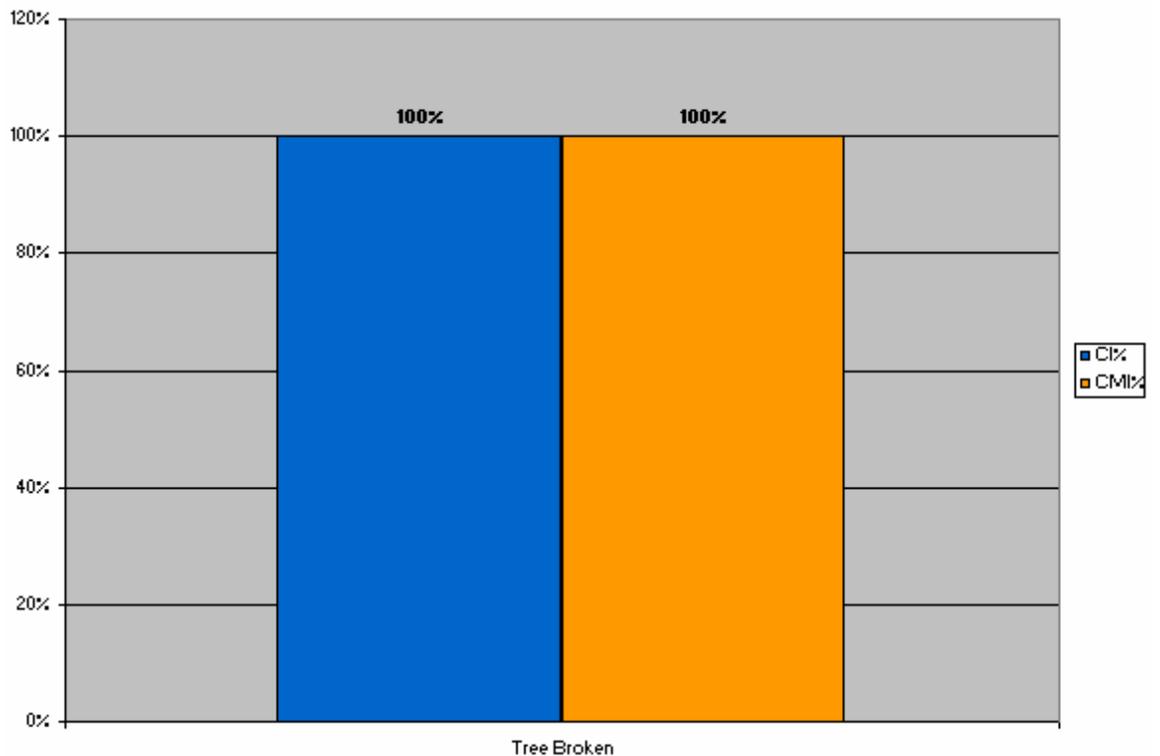
Figure 29 - 2005 WPC - L08225 - Decatur by Cause

This circuit was a worst performer from a CAIDI perspective. It is a 4 kV urban circuit that serves 632 customers. Figure 29 shows the percentage of CI and CMI by cause code for 2005.

This circuit experienced one outage in 2005 that affected eleven customers. A tree limb fell into the line and caused the fuse to trip. The branch was removed and the fuse was closed in and held. This outage was extended due to the fact that it occurred immediately following the June 13, 2005 severe wind storm and was prioritized for restoration along with all other outages. The circuit will be patrolled in the second quarter of 2006 and any maintenance work identified as a result of the patrol will be completed in 2006. Cost estimates are not available at this time.

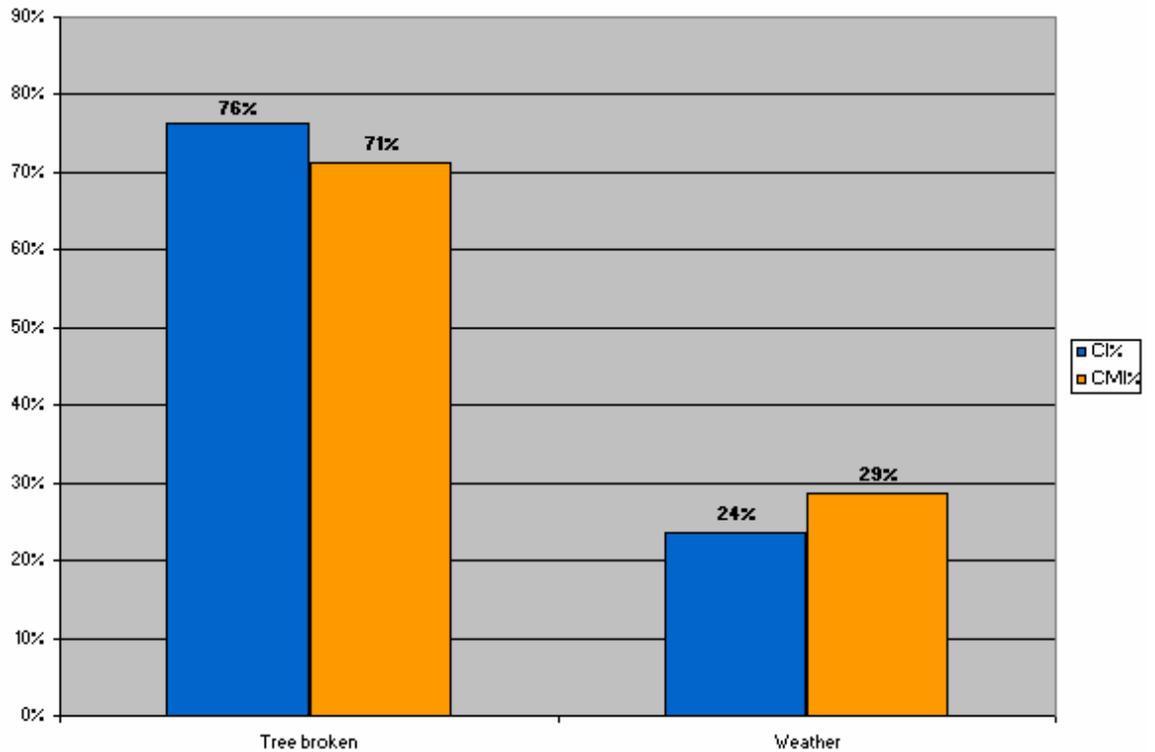
Figure 30 - 2005 WPC - L11242 - Decatur by Cause

This circuit was a worst performer from a CAIDI perspective. It is a 4 kV urban circuit that serves 680 customers. Figure 30 shows the percentage of CI and CMI by cause code for 2005.

This circuit sustained four separate outages in 2005, all of which were associated with the June 13, 2005 severe wind storm. Three of the four indicate tree branches fell into the primary. The other was shown as wind-related during the storm. Outside of this one storm, the circuit performed well in 2005. Regardless, AmerenIP will patrol the circuit and develop any corrective work plans accordingly. Cost estimates are not available at this time.

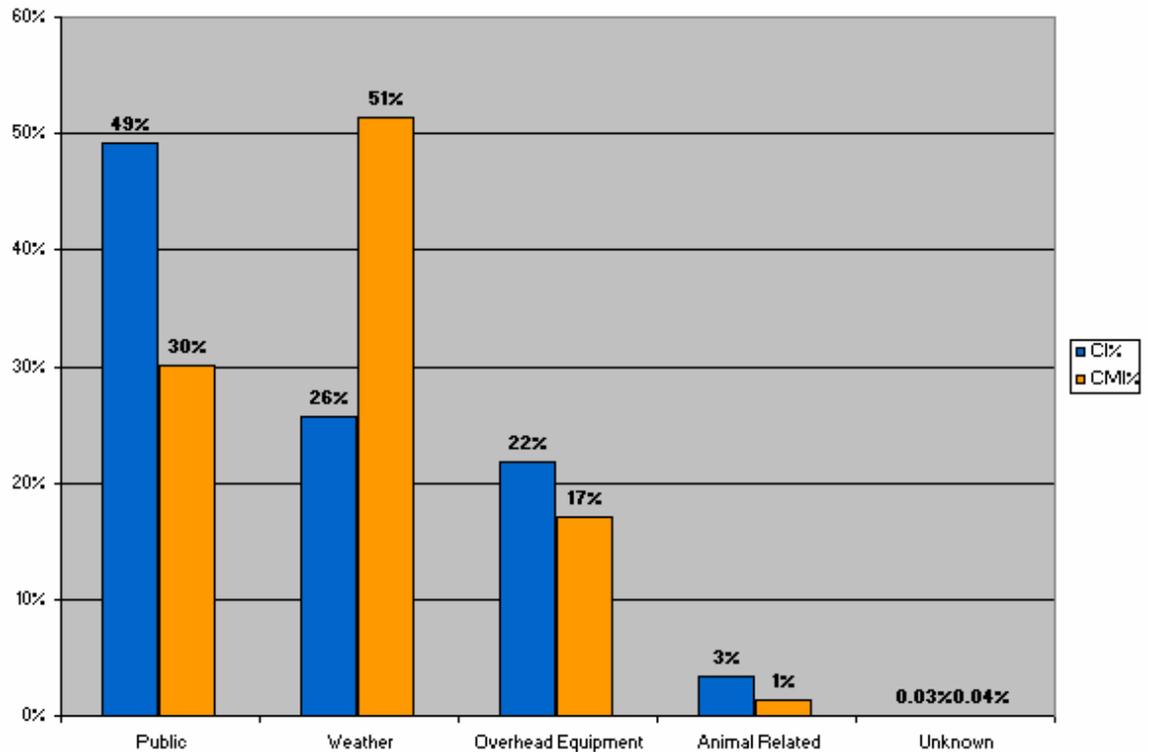
Figure 31 - 2005 WPC - L17101 - Decatur by Cause

This circuit was a worst performer from both SAIFI and CAIFI perspectives. It is a 12 kV urban circuit that serves 903 customers. Figure 31 shows the percentage of CI and CMI by cause code for 2005.

This circuit experienced a total of sixteen outages during 2005, including three vehicle, three overhead equipment malfunction, five wind, four animal and one unknown caused outages. The majority of CMI was due to two wind storm incidents on May 11 and June 13, 2005.

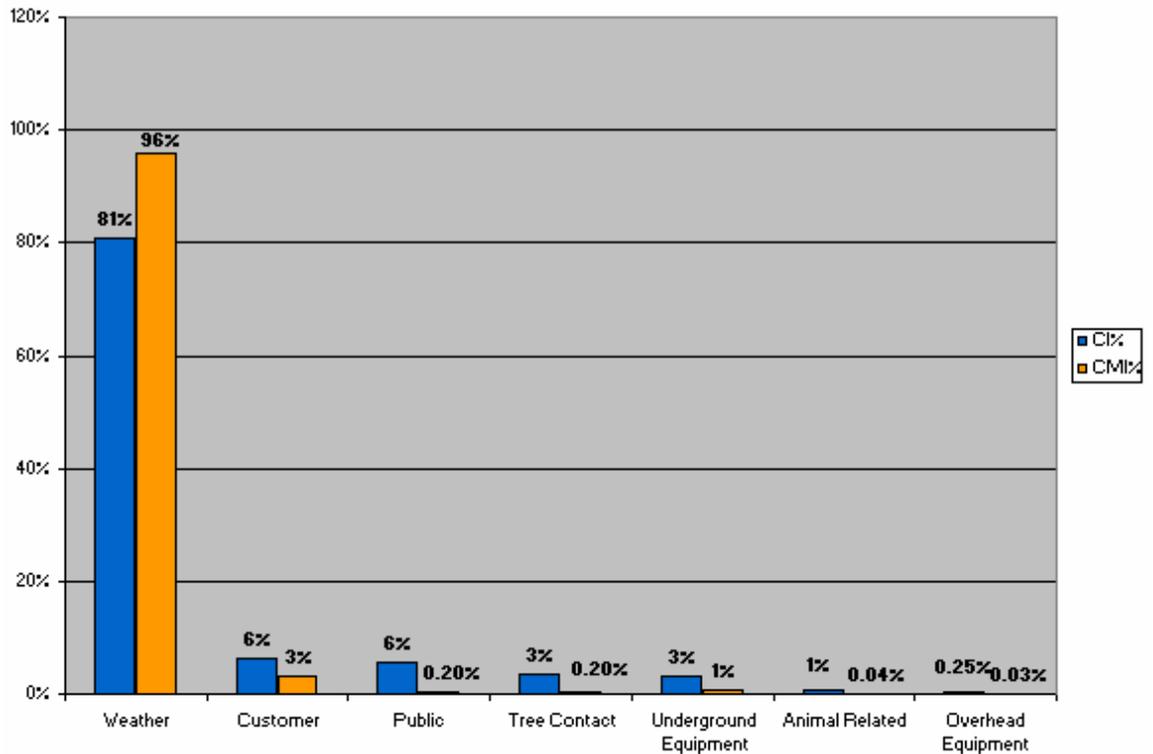
Figure 32 - 2005 WPC - L17104 - Decatur by Cause

This circuit was a worst performer from a CAIDI perspective. It is a 12 kV urban circuit that serves 748 customers. Figure 32 shows the percentage of CI and CMI by cause code for 2005.

This circuit will be patrolled the second quarter of 2006. The majority of the CMI occurred during the wind storm of June 13, 2005 with much of the balance being caused by public vehicle accidents or customer equipment failure. Any maintenance work identified as a result of the patrol will be completed in 2006. Estimated project costs are not available at this time.

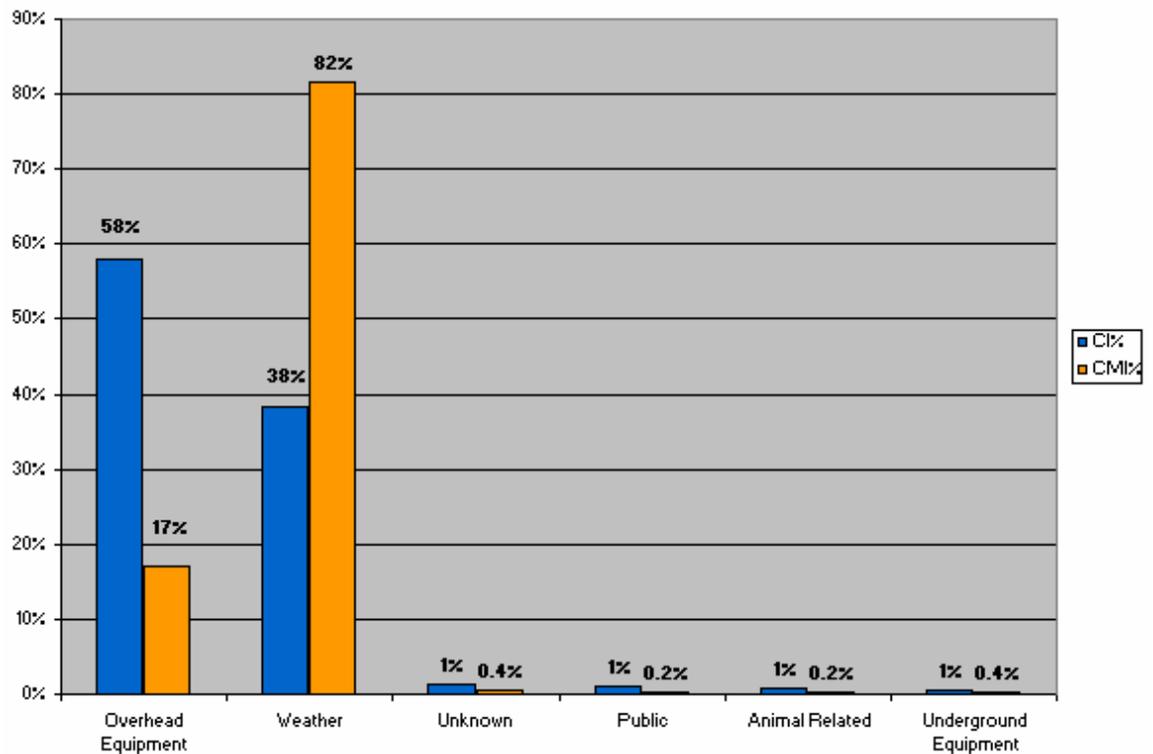
Figure 33 - 2005 WPC - M81402 - Pontoon Beach by Cause

This circuit was a worst performer from a CAIFI perspective. It is a 12 kV urban circuit that serves 1,257 customers. Figure 33 shows the percentage of CI and CMI by cause code for 2005.

Overhead equipment related-outages contributed to the majority of customer interruptions in 2005. AmerenIP contracted with a pole inspection expert in the spring of 2006. A total of 729 poles were tested on this fifteen-mile circuit. As a result, several poles will be replaced or restored. Corrective maintenance items include replacing defective or missing hardware, installing missing guy guards, and replacing several crossarms. This work will be completed in 2006 at an approximate cost of \$29,000. Additionally, Company engineering staff will assess the condition of several leaning poles and split or decayed pole tops to determine if additional actions are warranted at this time.

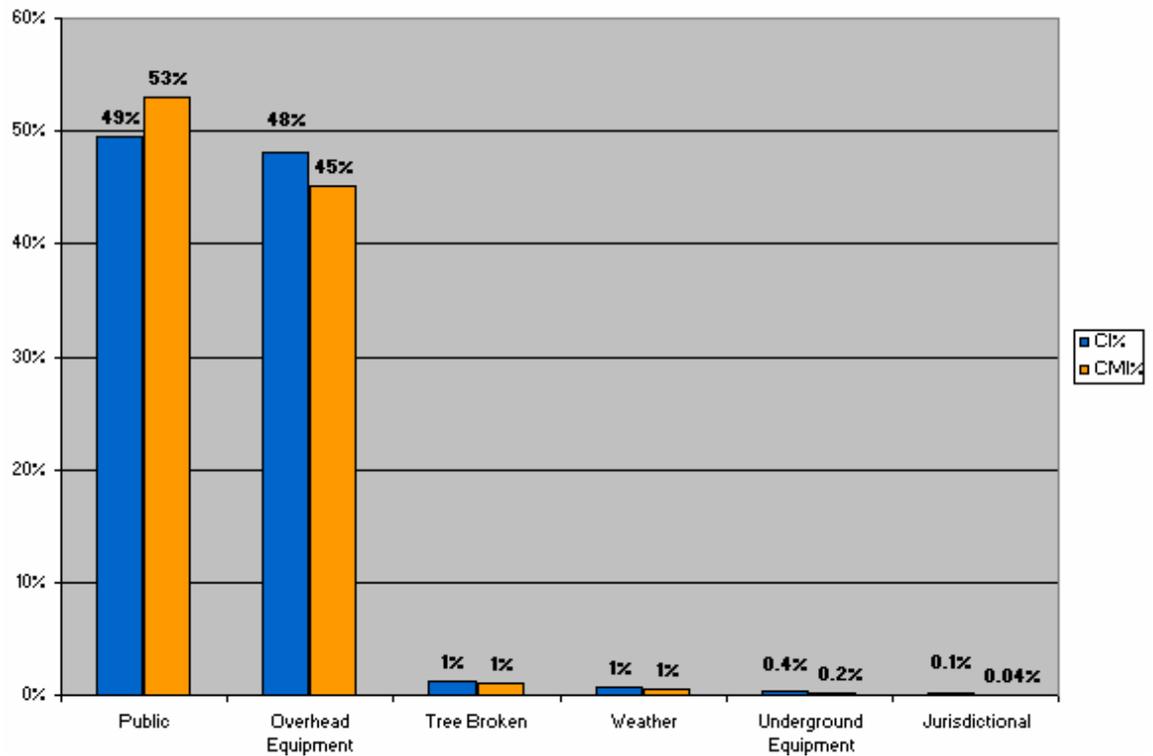
Figure 34 - 2005 WPC - P52306 - Monticello by Cause

This circuit was a worst performer from a SAIFI perspective. It is a 12 kV rural circuit that serves 806 customers. Figure 34 shows the percentage of CI and CMI by cause code for 2005.

This circuit experienced outages with varied causes in 2005. Among them were lightning, underground failure and a building which was being demolished dropped on the main feeder. The circuit trim was completed in November 2005. Significant changes occurred on this circuit in late 2005. A new feeder (Circuit 341) was extended from Monticello Rt. 105 substation. This feeder now serves approximately a little over half of what was circuit P52306. The vast majority of the remainder of the circuit is now served by Circuit 305. Very little of the old circuit P52306 remains as it was configured during most of 2005. The extension of the new feeder was an effort to improve reliability in the Monticello area by making a second distribution substation available and splitting the load on the existing two 12 kV circuits among three. Additionally, this circuit was trimmed in November 2005.

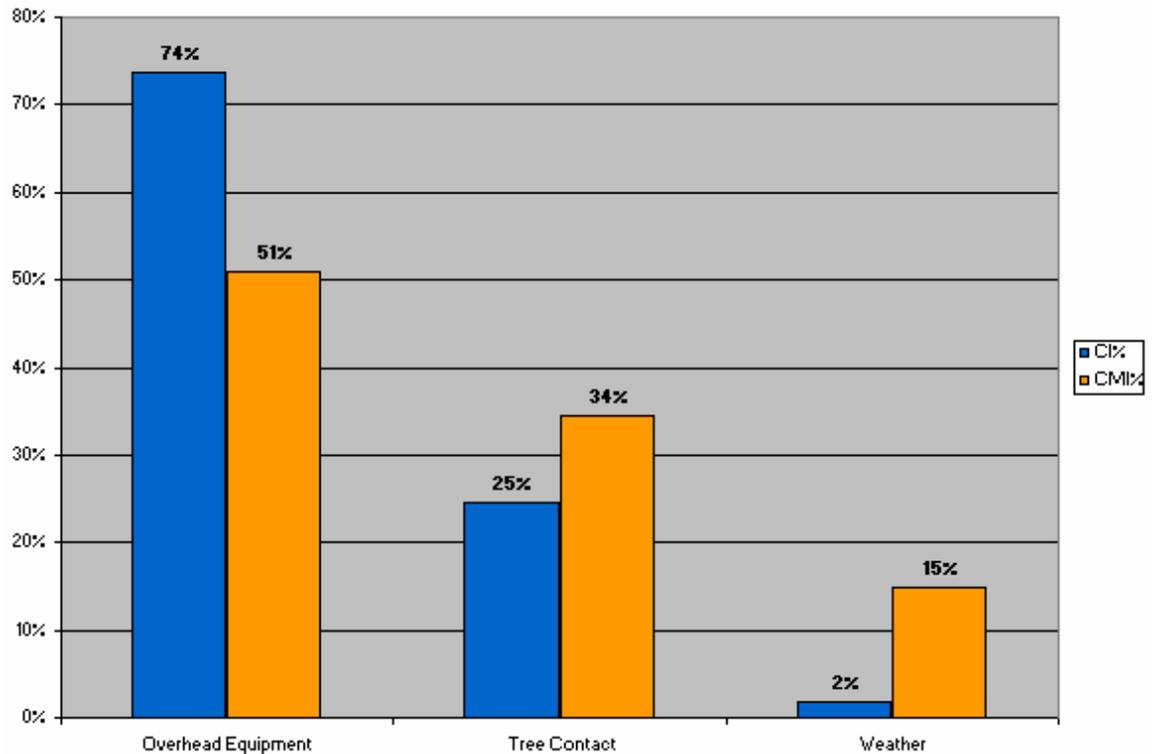
Figure 35 - 2005 WPC - P58155 - Mt. Vernon by Cause

This circuit was a worst performer from both SAIFI and CAIFI perspectives. It is a 12 kV urban circuit that serves 1,489 customers. Figure 35 shows the percentage of CI and CMI by cause code for 2005.

In late 2004, approximately 700 ft of underground cable was replaced. Three sets of three-phase disconnect switches were installed to enhance load transfer and sectionalizing capabilities; this work was completed in January 2006. Approximately 1300 ft. of spacer cable has been replaced along Casey Avenue; 400 ft. was replaced in June 2005 and 900 ft was replaced in January 2006. This work was completed at a cost of \$76,000.

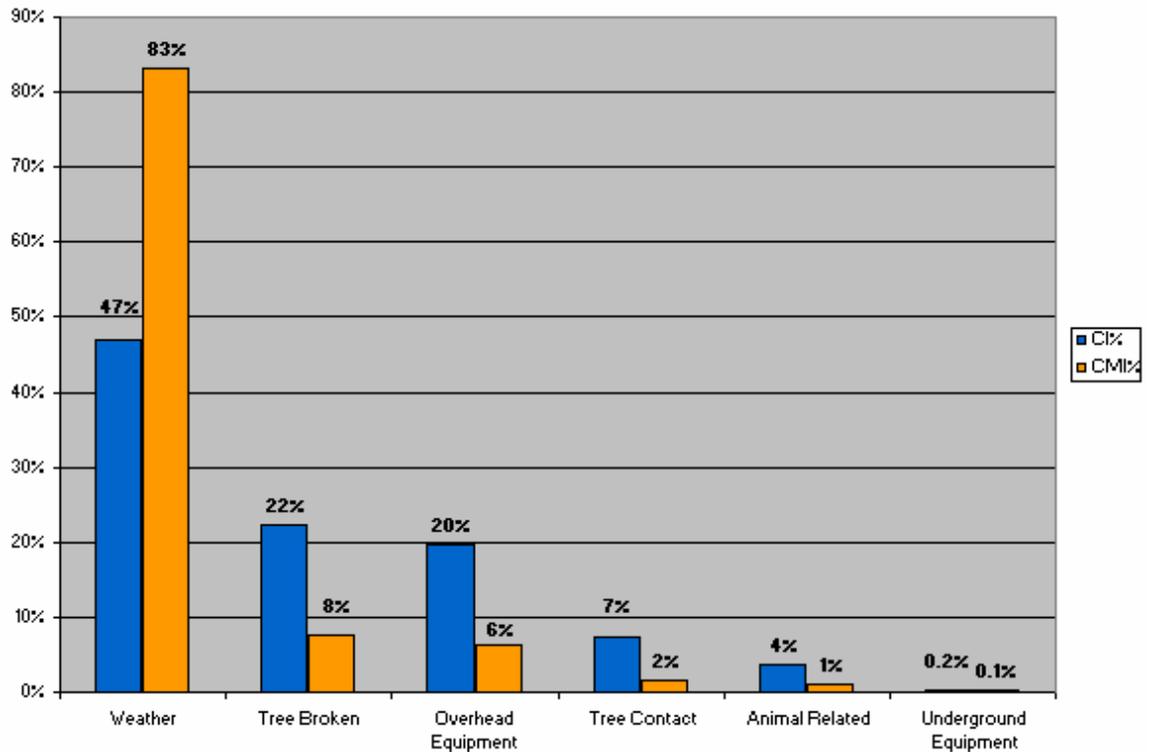
Figure 36 - 2005 WPC - Q23256 - O’Fallon by Cause

This circuit was a worst performer from both SAIFI and CAIFI perspectives. It is a 12 kV urban circuit that serves 1,171 customers. Figure 36 shows the percentage of CI and CMI by cause code for 2005.

A variety of outage causes impacted this circuit during 2005, although a single thunderstorm had the biggest impact on customers. In addition to installing new equipment as necessary at the time of the outages, the Company has taken several steps to address reliability. In May of 2005, work was completed to install a normally open tie switch at Route 50 and Seven Hills Road at an approximate cost of \$3,000. This provides additional backup for electrical feed to customers on this circuit. This work will improve reliability by decreasing outage durations. AmerenIP will also complete installation of animal protection and insulated stingers by the end of 2006. Estimated project cost is \$7,500. A complete circuit-wide trim is scheduled for the third quarter of 2006.

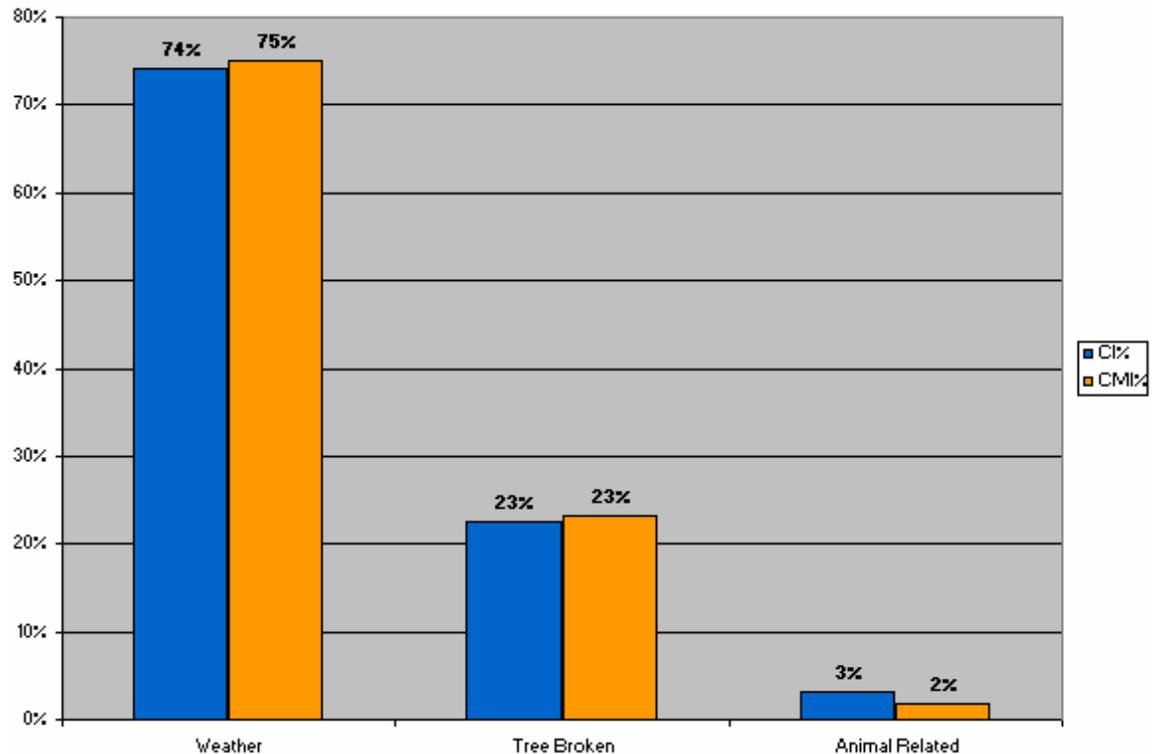
Figure 37 - 2005 WPC - Q27186 - Okawville by Cause

This circuit was a worst performer from a CAIFI perspective. It is a 12 kV rural circuit that serves 173 customers. Figure 37 shows the percentage of CI and CMI by cause code for 2005.

A two-mile stretch of line was responsible for nearly all of the outages in 2005. AmerenIP's evaluation will address any forestry issues, load concerns, and animal and lightning protection. Animal guarding is scheduled to be completed by October 2006. Maintenance items will be corrected as necessary. During 2004, lightning-damaged regulators were replaced and a set of reclosers was installed. A full circuit trim was completed in December 2005. Cost of this work is approximately \$34,000.
