Response to 83 Illinois Administrative Code
411 – 2005 Annual Report
Revised July 21, 2006

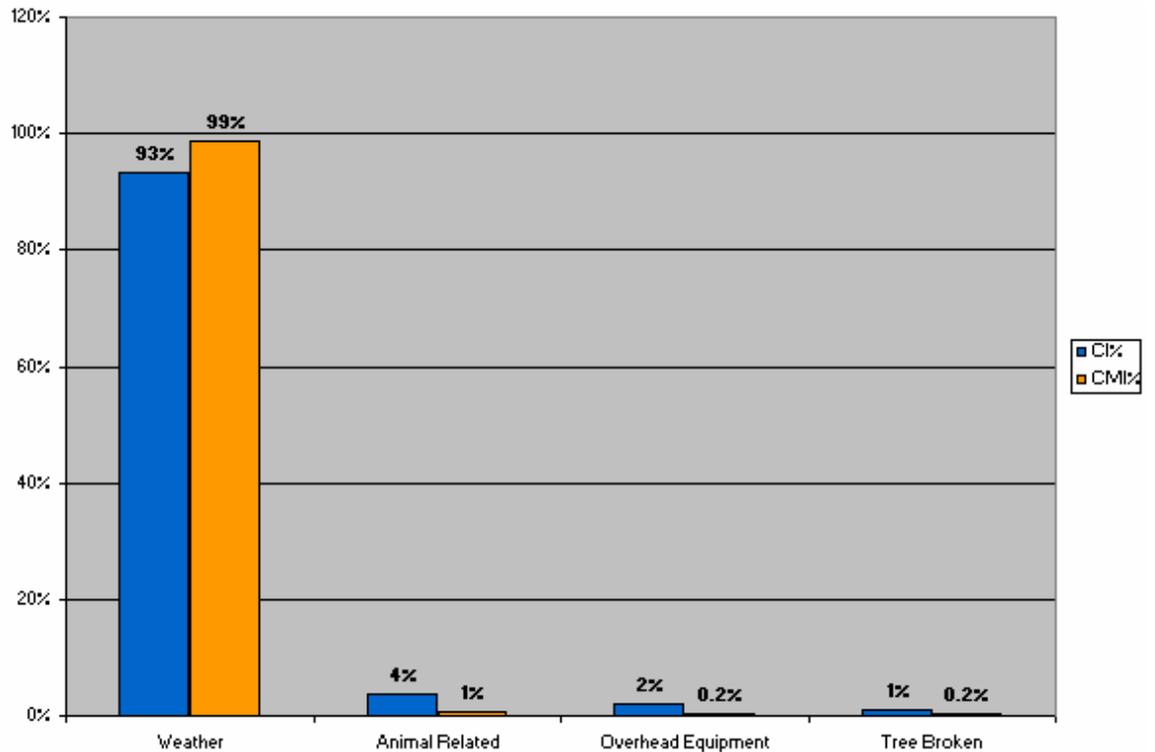
Figure 38 - 2005 WPC - R20502 - St. Joseph by Cause

This circuit was a worst performer from a CAIDI perspective. It is a 12 kV rural circuit that serves 489 customers. Figure 38 shows the percentage of CI and CMI by cause code for 2005.

This circuit experienced three January ice storm-, three animal-, and two lightning-related outages, among a few others, during 2005. Due to a higher than normal SAIFI during 2004, extensive attention was given to this circuit in 2005 and early 2006. A review of the protective coordination yielded a total of 10 additional fuses and one additional set of reclosers; this work was completed in May 2006 at an approximate cost of \$10,800. A circuit inspection and pole testing showed that several poles needed reinforcement and in excess of 40 other poles should be replaced. In addition, numerous maintenance items were identified. The majority of this work was completed in 2005 and early 2006. Approximate cost of the pole replacement work was \$120,000.

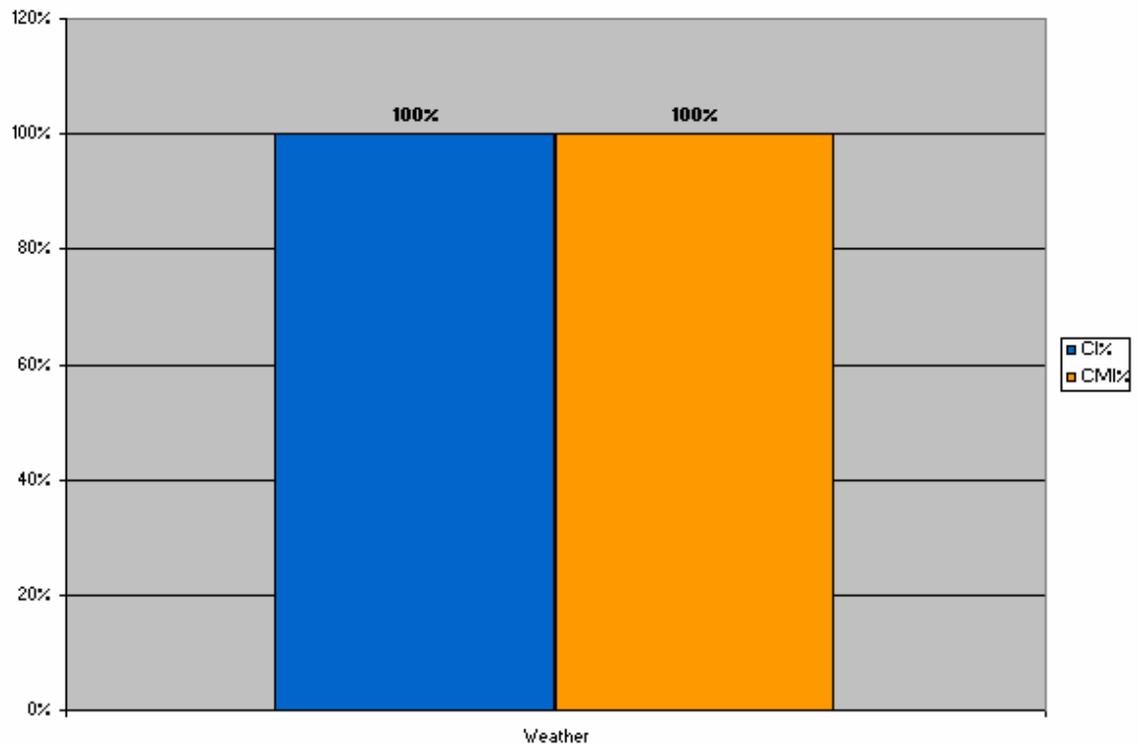
Figure 39 - 2005 WPC - R58922 - Urbana by Cause

This circuit was a worst performer from a CAIDI perspective. It is a 4 kV urban circuit that serves 618 customers. Figure 39 shows the percentage of CI and CMI by cause code for 2005.

This circuit experienced only one outage in 2005 due to the January ice storm. The circuit tree trim was completed in May 2005. After a review of the condition of this circuit, it appears replacement of four poles and fuses at two locations is warranted. This work will be completed in 2006 at a cost of \$10,000.

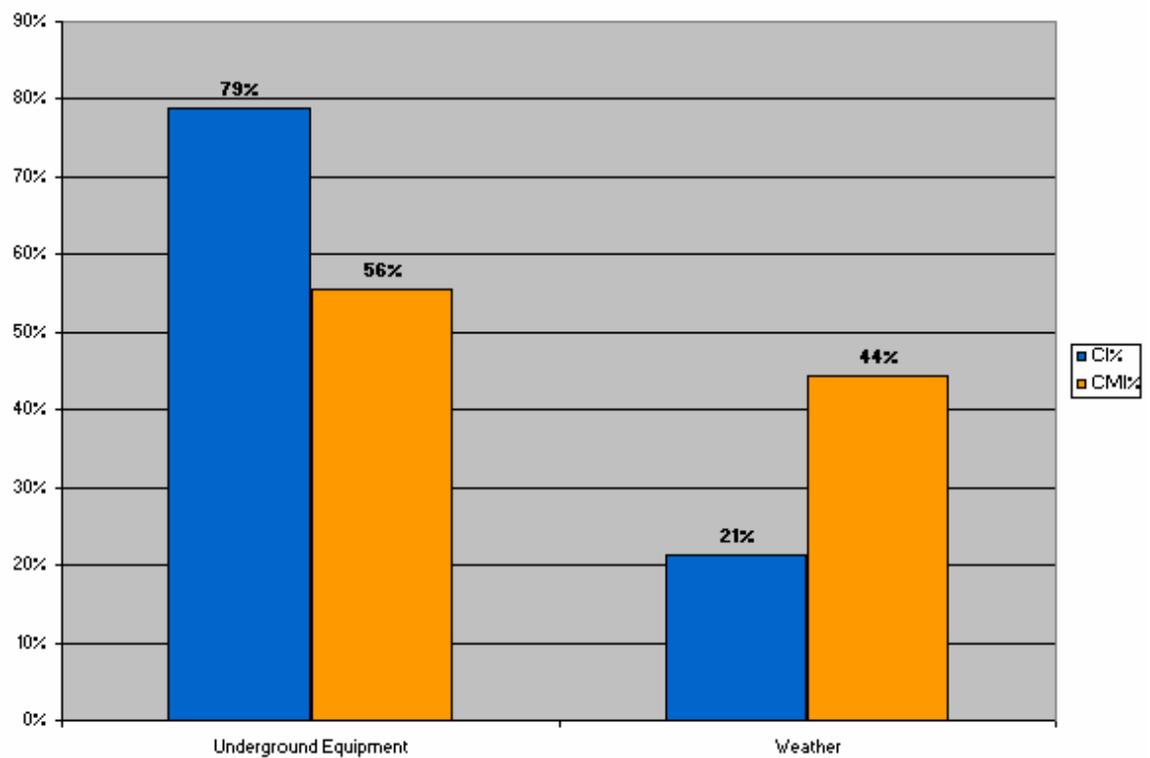
Figure 40 - 2005 WPC - R58931 - Urbana by Cause

This circuit was a worst performer from a CAIDI perspective. It is a 4 kV urban circuit that serves 232 customers. Figure 40 shows the percentage of CI and CMI by cause code for 2005.

Only two outages occurred on this circuit in 2005. One was due to an ice storm in January and the other was due to an underground failure. The patrol performed in the spring of 2006 revealed only a few maintenance items that need to be corrected. This work will be completed in 2006 at an estimated cost of \$1,000. The circuit-wide trim was completed in August 2005.

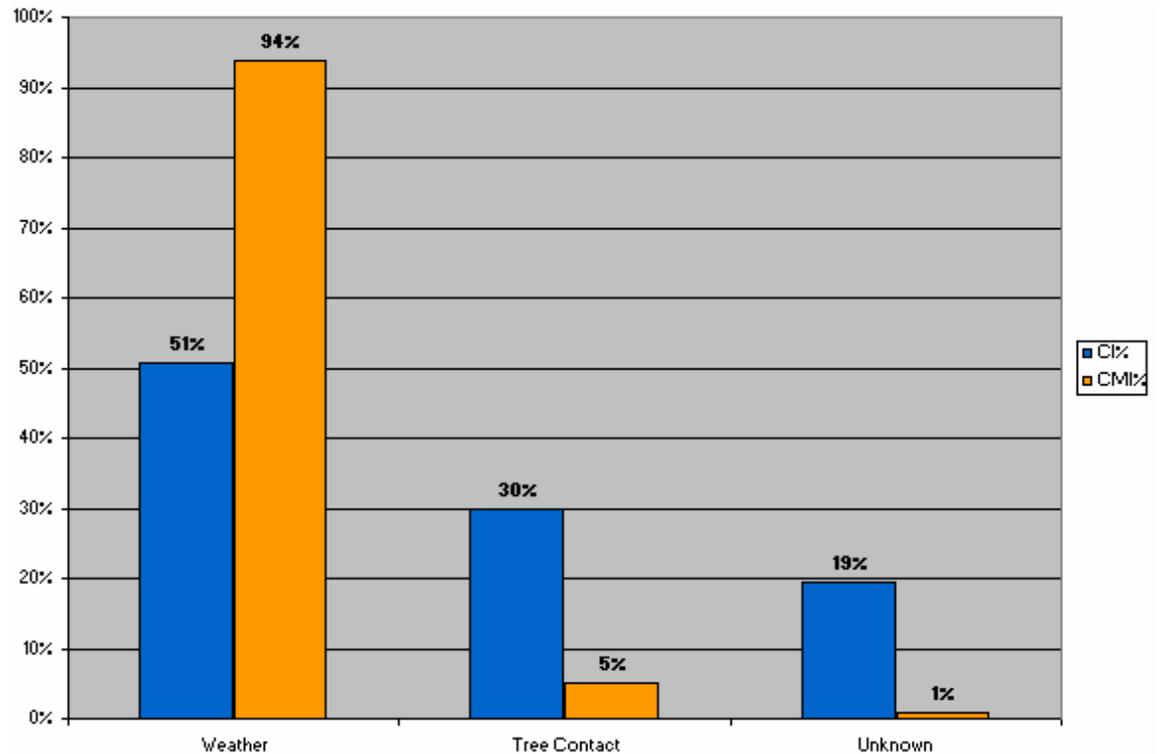
Figure 41 - 2005 WPC - R58932 - Urbana by Cause

This circuit was a worst performer from a CAIDI perspective. It is a 4 kV urban circuit that serves 682 customers. Figure 41 shows the percentage of CI and CMI by cause code for 2005.

This circuit experienced three separate outages in 2005. Circuit tree trimming was completed in March 2005. A field check of the circuit in early 2006 showed that in addition to a few minor maintenance items, replacement of two spans of old copper single phase primary, nine poles, and the addition of four fuses would be beneficial. Approximate cost is estimated at \$28,000 and work will be completed prior to December 2006.

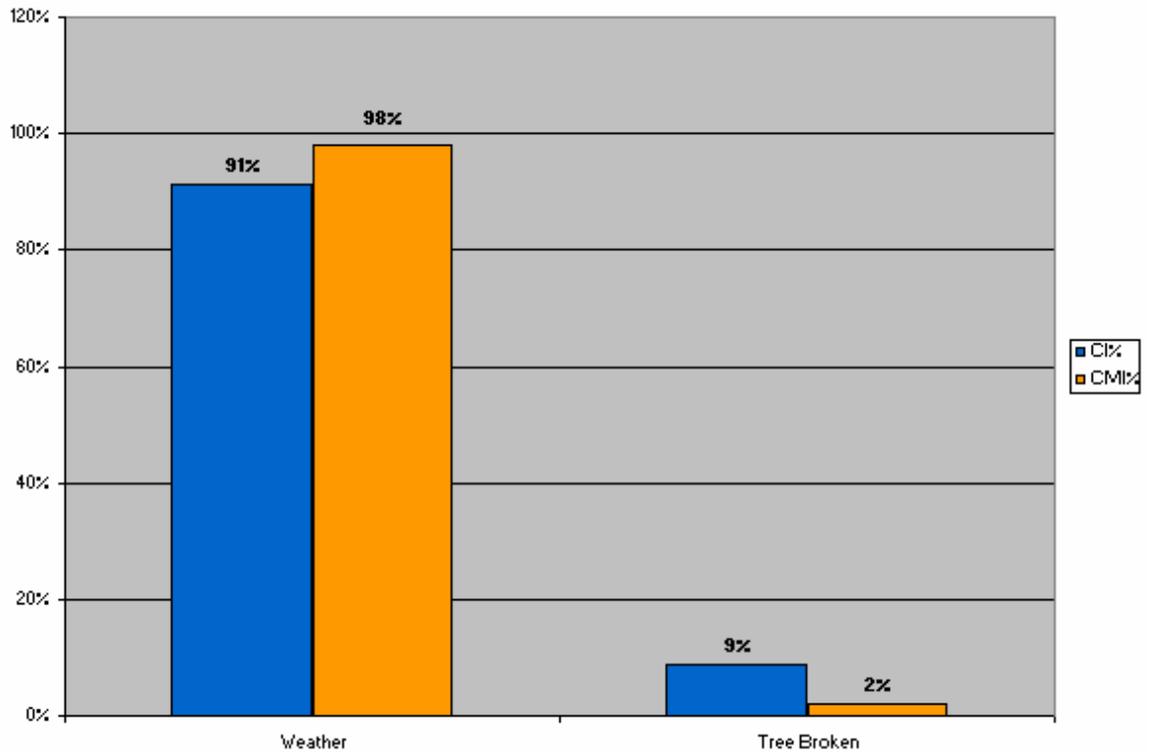
Figure 42 - 2005 WPC - R59411 - Urbana by Cause

This circuit was a worst performer from a CAIDI perspective. It is a 4 kV urban circuit that serves 345 customers. Figure 42 shows the percentage of CI and CMI by cause code for 2005.

This circuit experienced four outages in 2005. Two outages were due to the January ice storm, one due to lightning and one (service only) due to trees. Review of the condition of this circuit showed that minor maintenance work, including replacement of a few primary spacers, a few lightning arresters and one pole were warranted. Also, addition of two fuses and modifications of the sizing of four other fuses would be beneficial. Estimated cost is approximately \$2,000 and all work will be completed by year end.

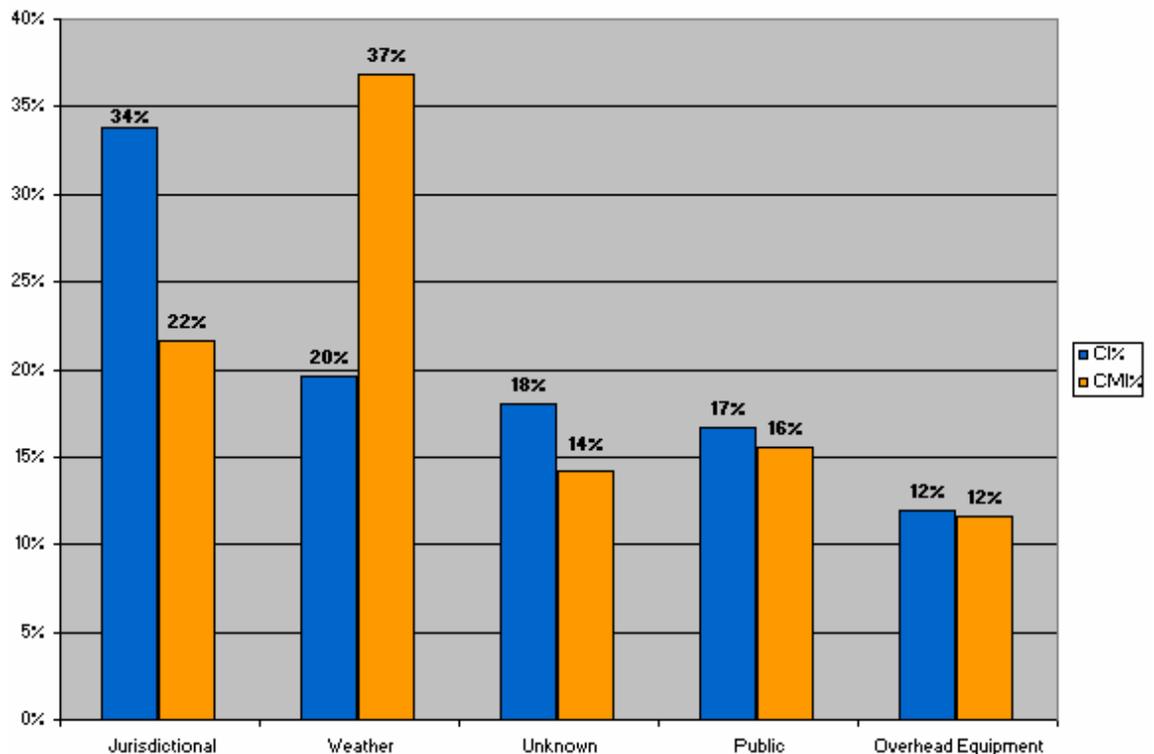
Figure 43 - 2005 WPC - R78300 - Venice, Brooklyn by Cause

This circuit was a worst performer from a SAIFI perspective. It is a 4 kV urban circuit that serves 497 customers. Figure 43 shows the percentage of CI and CMI by cause code for 2005.

The biggest impact to customers on this circuit occurred during May and June storms and when a line contractor performing work on a transmission line bumped the distribution. Various other causes, including a truck that pulled a line down in Venice, contributed to the performance of this circuit. As a result, the Company contracted with a pole inspection expert in the spring of 2006. All 487 poles on this ten-mile circuit were inspected. As a result, four poles will be replaced and several maintenance items, including broken, missing, or defective hardware will be replaced. This work will be completed during 2006 at a cost of \$11,500. AmerenIP engineering personnel will also assess several leaning poles and pole tops that are decayed or have split tops to determine if additional work would be prudent at this point in time.

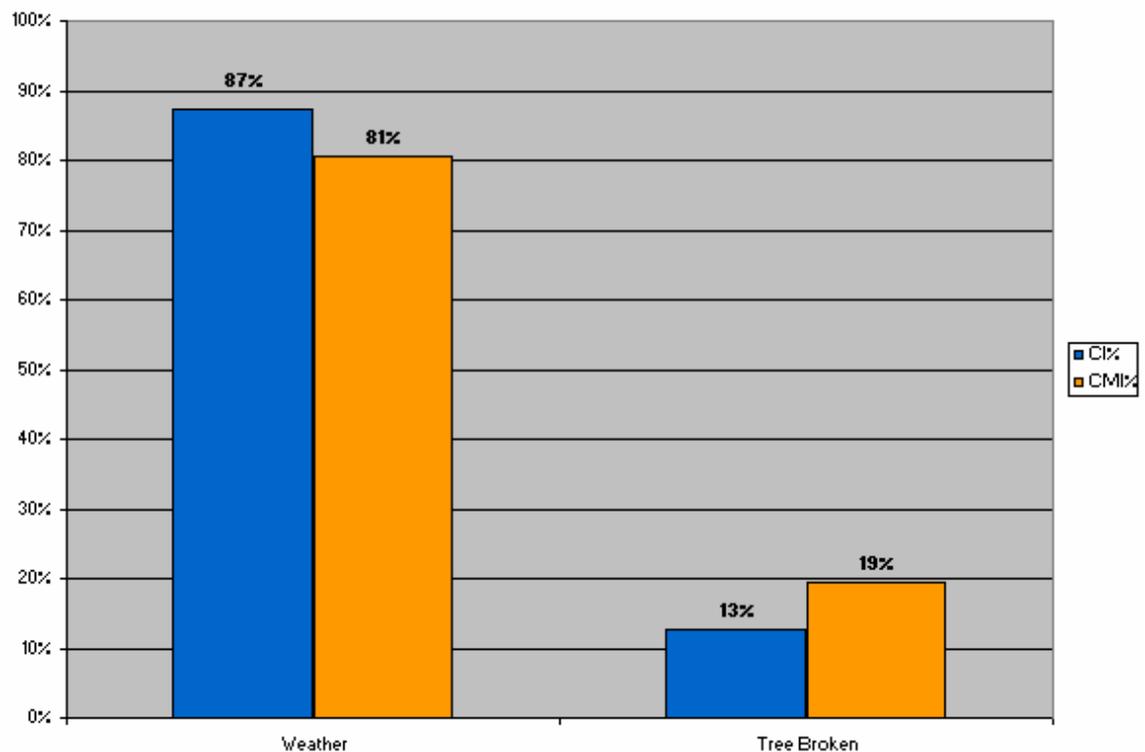
Figure 44 - 2005 WPC - R94271 - Waterloo by Cause

This circuit was a worst performer from a CAIFI perspective. It is a 12 kV rural circuit that serves 170 customers. Figure 44 shows the percentage of CI and CMI by cause code for 2005.

A coordination review was done on three reclosers on this circuit after an improper operation during a fault occurrence. One of the reclosers was improperly set, and this condition was corrected in September 2005.

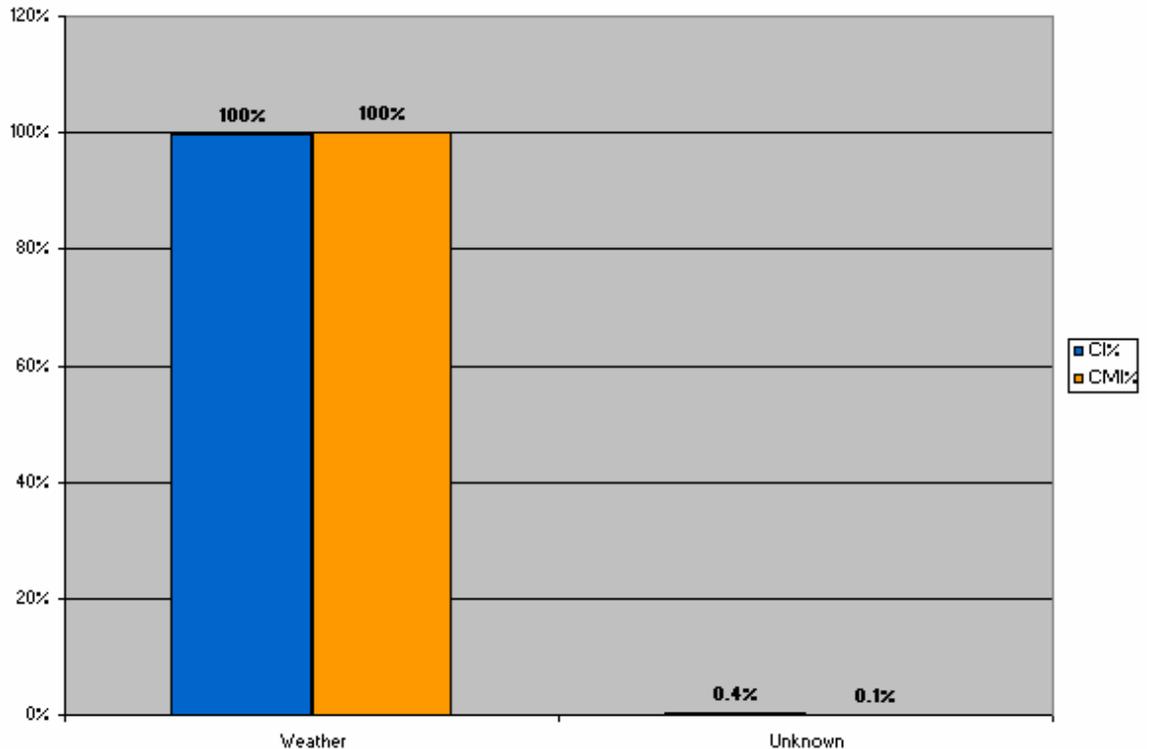
Figure 45 - 2005 WPC - R99180 - Farmer City by Cause

This circuit was a worst performer from a SAIFI perspective. It is a 12 kV rural circuit that serves 68 customers. Figure 45 shows the percentage of CI and CMI by cause code for 2005.

This circuit experienced several outages due to a mid-January ice storm. There also were six lightning-related outages during 2005. Field review of the circuit in early 2006 showed that maintenance work, including replacement of some lightning arrestors and cross arms, was warranted. It also appears that replacement of approximately seventeen poles, and the addition of five sets of lightning arresters and three fuses would be beneficial. Approximate cost of the non-maintenance work is \$37,500. This work will be completed by December 2006.
